Bearing Failure Analysis on Gearbox Forced Draft Fan at LNG Plant

Boilers Forced Draft Fan has a gearbox reducer to reduce speed from steam turbine as a driver and fan as the driven. Based on Predictive Maintenance Group at Machinery and Heavy Equipment Section, it was found that gearbox has high vibration and noise when boilers load on 195 Ton/Hr (Max Load 295 Ton/hr). Vibration Analysis indicates that the source of vibration comes from bearings with peak value 0.572 in/sec at gearbox high speed outboard vertical and 0.593 in/sec at gearbox high speed outboard horizontal (Max Allowance 0.50 in/sec). Lubrication analysis using X-ray Fluorescence method, to see wear particle on lubricating oil showed that Tin(Sn) content is very high 203.62 mg/L (maximum allowance for Tin(Sn) at gearbox is 20mg/L), but wear debris are not found in lubricating oil. Gearbox disassembly found that high speed and low speed bearings suffered severe corrosion. Corrosion at bearings are caused by water contamination on lubrication oil, it comes from steam leak due to carbon ring failure at steam turbine, which is steam turbine bearing lubrication and gearbox lubrication get into one lubrication system. Af

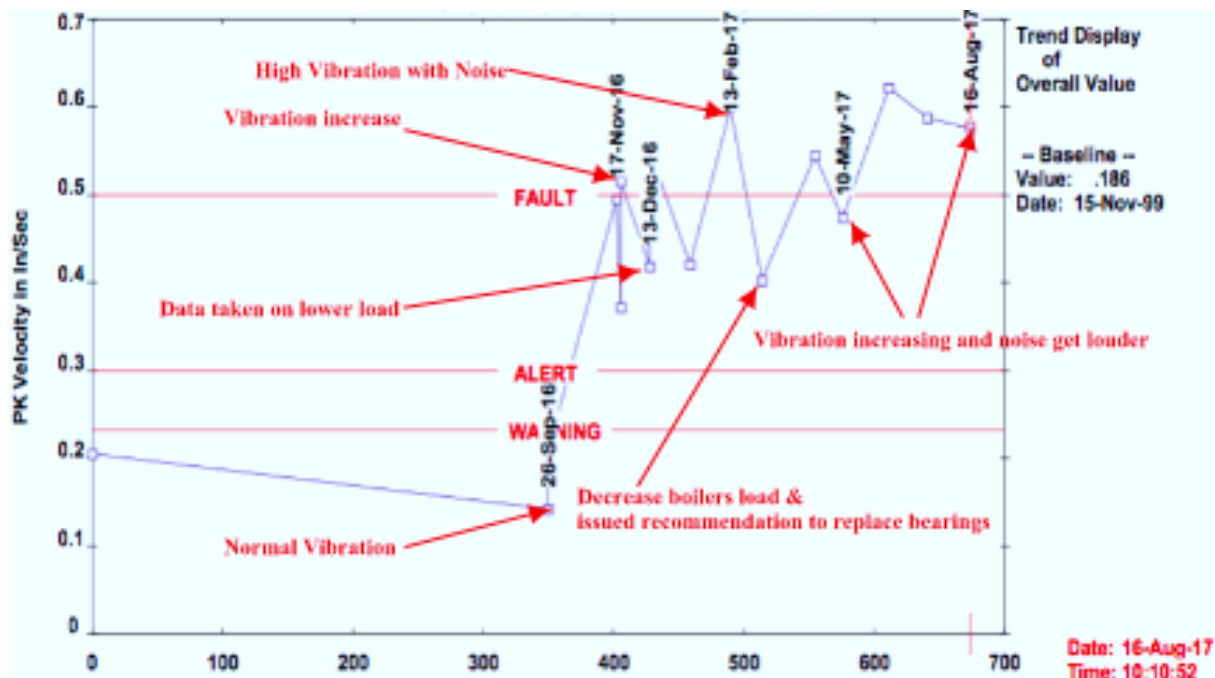
For example, there was an interesting case and described in several reports (Kjer, 1981; Peng *et al.*, 2005; van Zyl & Al-Sahli, 2013)). On September 26, 2016, gearbox vibration is in normal condition, then on November 17, 2016, gearbox vibration began to increase and exceed maximum allowance value, which is 0.52 in/sec (Max allowance 0.50 in/sec) where the data are taken on the high load. After the workload is lowered on Desember 13, 2016, the data are taken on the low load where there is a decrease in vibration to 0.46 in/sec. On Februari 13, 2017, the data are taken on the high load and found the vibrations become higher 0.59 in/sec followed by the noise on the gearbox. On March 2, 2017, Maintenance Department issued a recommendation to replace Bearings, because bearing purchase takes six months and due to operational needs then Boilers Forced Draft Fan is recommended to operate with no more load than 150 Ton/hr (see Figure 1).

Figure 1. Overall Vibration Trending History

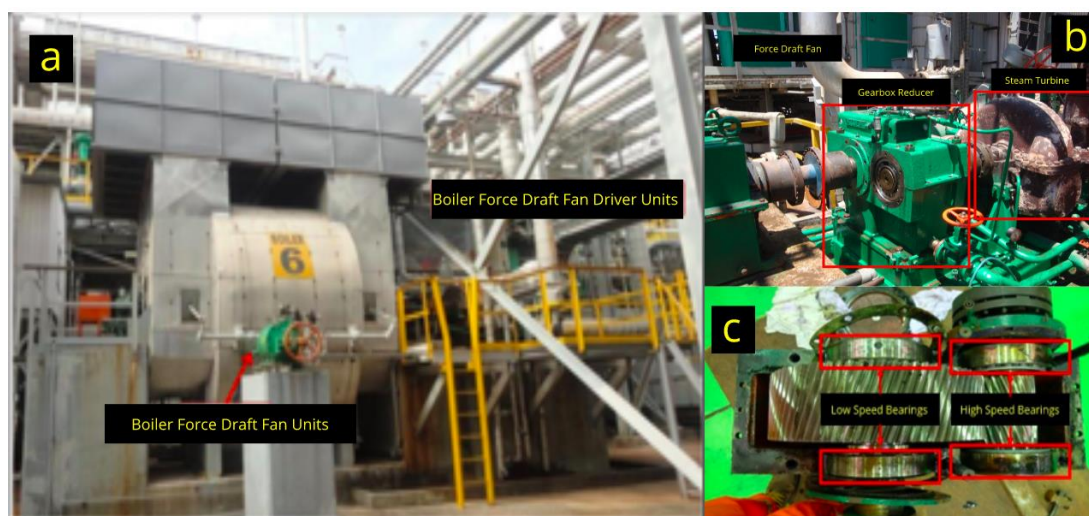
Figure 2. Schematic figure of Boiler Force Draft Fan (a) Gearbox reducer location (b) and Its broken bearing (c)

Figure 2c shows the detailed conditions of the inside of the gearbox that experience high vibration consisting of gearbox housing, high speed gear, low speed gear, shafts, high speed bearings, and low speed bearings. The gear condition is still good and shows no signs of failure while bearing conditions indicate the condition of corrosion damage. Therefore, further analysis is needed to prove that high vibration in the gearbox reducer is due to bearing failure.

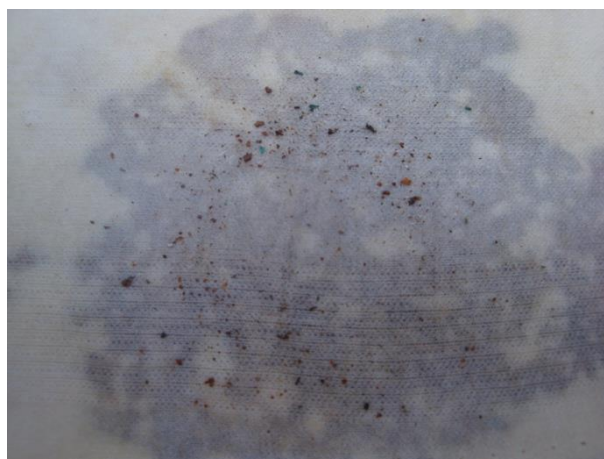
Figure 5 shows the results of filtering the lubricant on the gearbox. Based on the filtration results, there is no visible metal flakes with large size that can be seen by the eye, so that filtration data cannot be used to do damage analysis on gearbox components.

Figure 5. Results of filtering gearbox lubricants

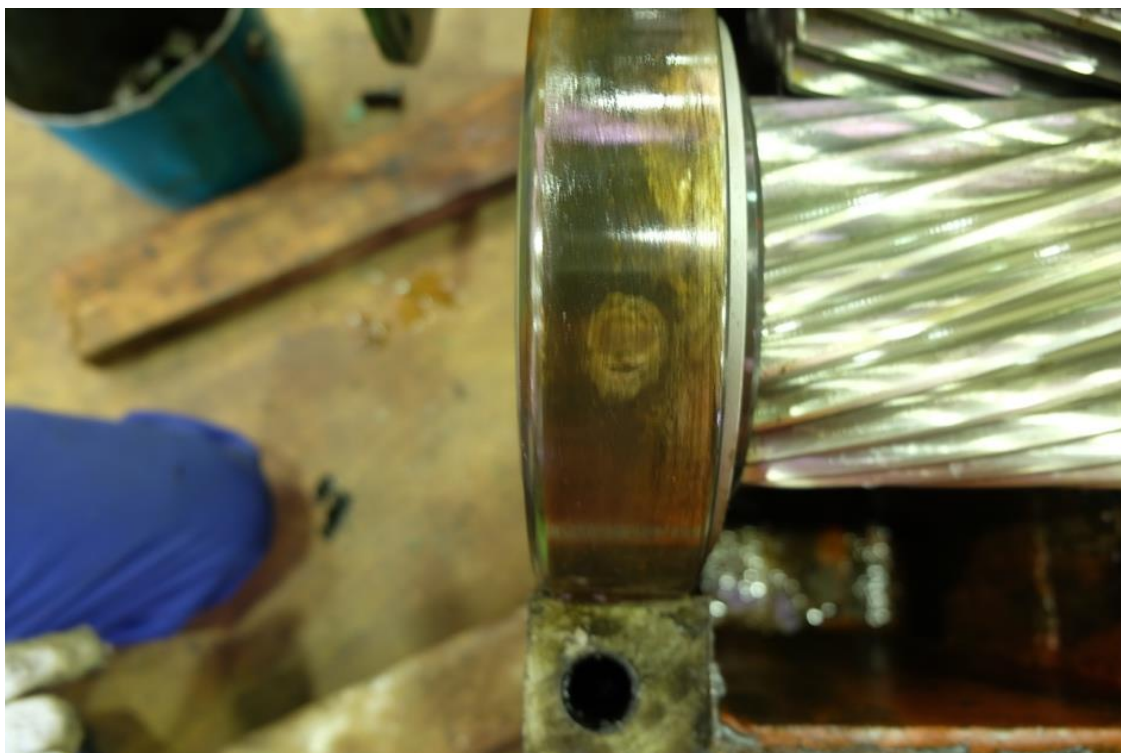
Visual examination of the failed bearings revealed that it suffered severe corrosion. **Figure 6** shows bearings location inside gearbox housing. The condition of bearing is covered by sludge, this sludge is formed because of the mixture of water and oil inside gearbox housing. And **Figure 4** shows the remaining water deposits in the bottom of the gearbox housing. This indicates that there has been contamination of water in the lubricant system.

Figure 6. Sludge on the bearing

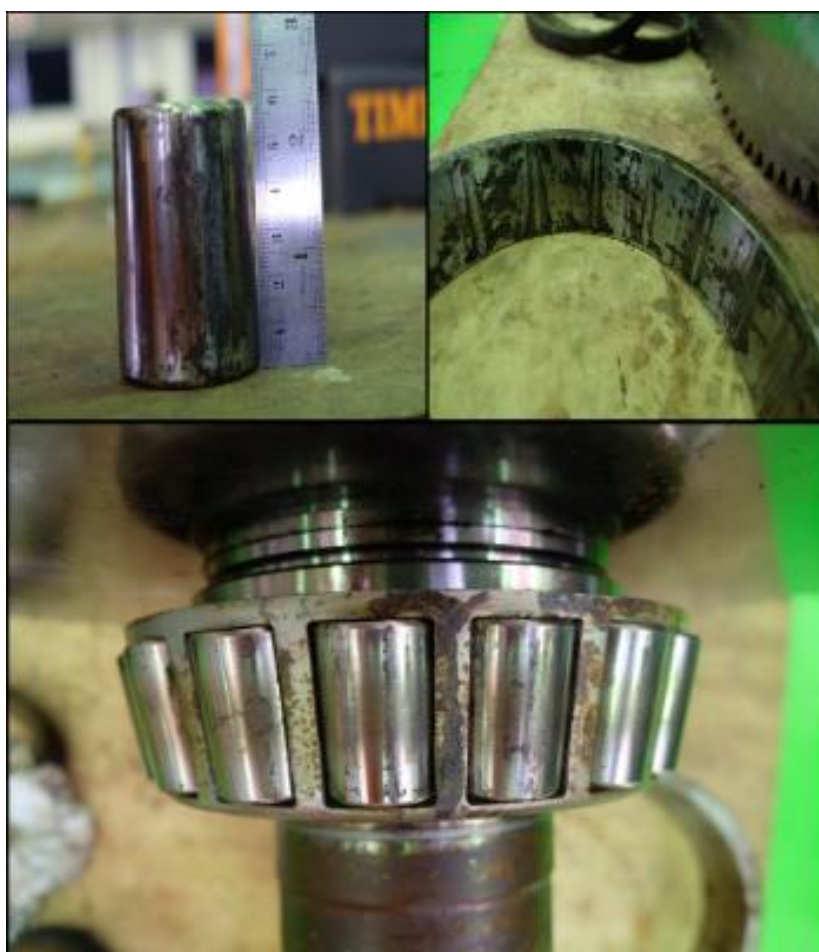
Visual appearance of the corroded bearings (shown in **Figure 8**) is clearly visible that the damage is caused by the corrosion. Based on literature and references from

bearing manufactures "TIMKEN" corrosion of the observed bearing is Etching or Corrosion (Ellis, 1970). Bearing cups have heavy corrosion on the race, cage, and roller. The stain on bearing cannot be cleaned with a fine emery cloth or crocus cloth and there is a pits that cannot be cleaned with light polishing.

Figure 8 shows the condition of the components in the corroded bearing, such as corroded rollers, corroded raceways, and corroded roller cages. This condition causes the bearing cannot be used and repaired so it is recommended to be replaced with a new bearing.

Figure 8. Bearing Cage, Roller, and Raceway Conditions

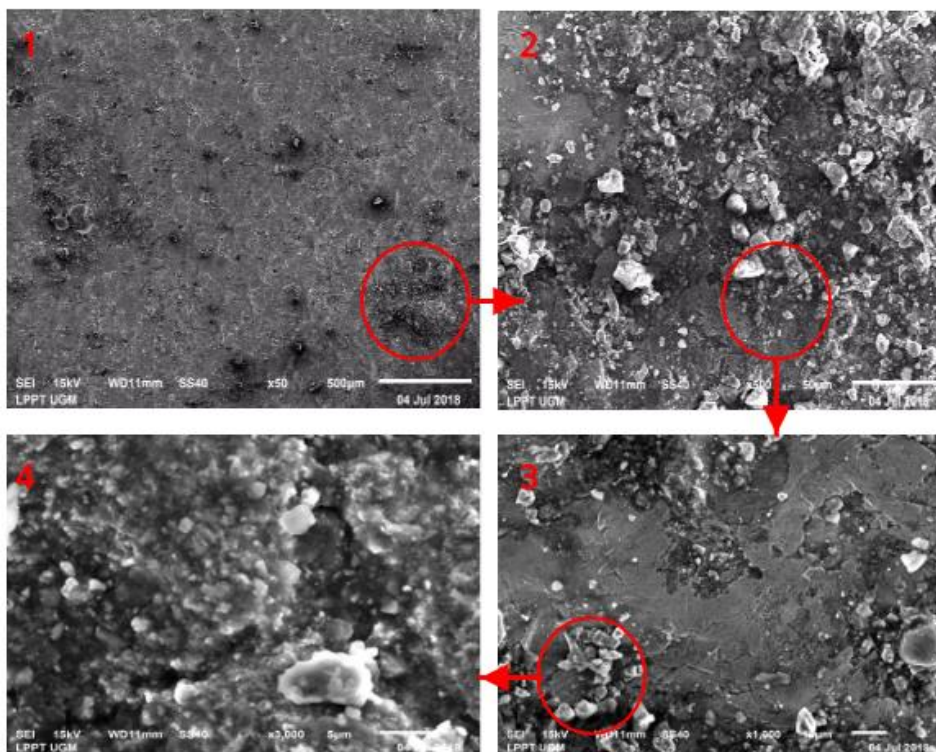
Figure 9 shows the condition of the metal that has been corroded. It is clear that the rust crust formed has changed the condition of the metal surface. Metal surfaces become rough and deformed this causes the metal to become brittle , as well as the appearance of stress concentration points which can be a source of failure in metals.

The microstructure, with corroded, revealed high quantity of rust crust compared to non-corroded metals as shown in **Figure 9** and **10**. Through magnification of x500 rust crust are clearly visible, in which the crust result in deformation of the metal. No visible deformation due to rust on non-corroded metals as shown in **Figure 10**. Rust affects changes in the composition of metal structures which result in metal conditions becoming brittle and susceptible to failure.

Figure 9. Scanning Electron Microscope result for corroded metals

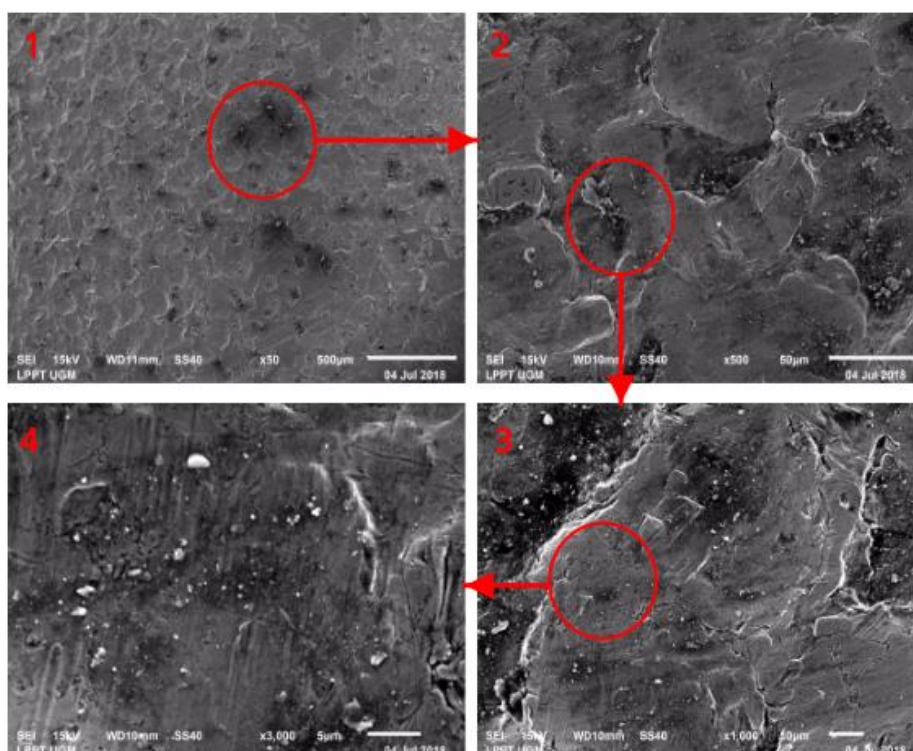
Figure 10 showed analysis that is carried out on non-corroded metals, the condition of

the metal surface is smoother and free of rust crust.

Figure 10. Scanning Electron Microscope result for non-corroded metals

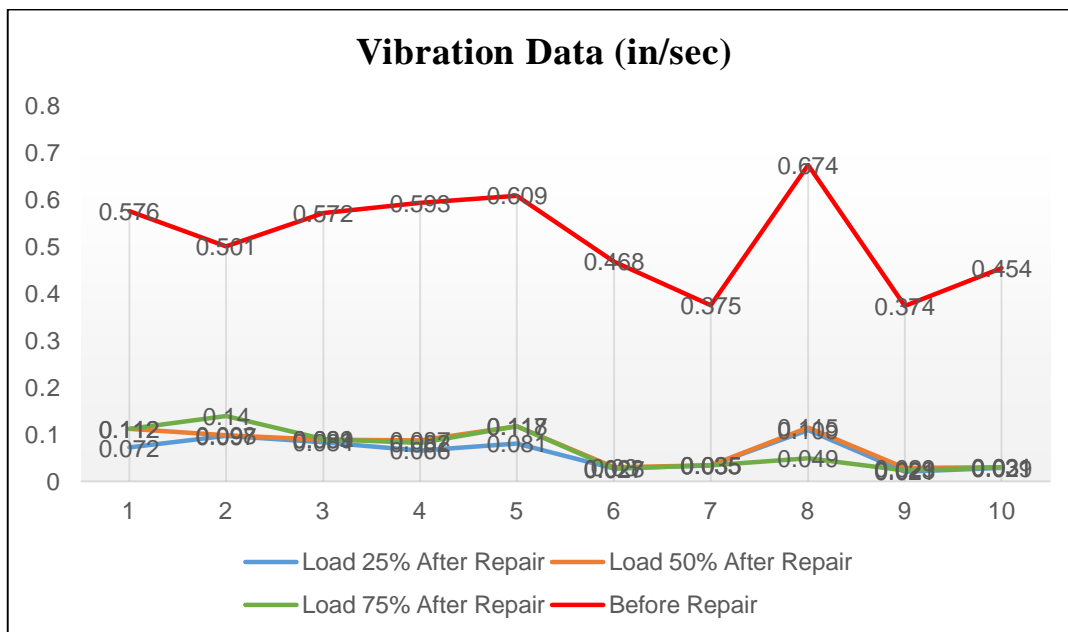
Figure 11 shows a curve of vibration measurement data before and after repair. The Chart shows the average vibration value after bearing replacement is below 0.2 in/Sec far from the maximum permissible limit of 0.5 in/Sec.

Figure 11. Comparison Chart Before and After Repair

After replacing the broken bearing with the new one, vibration data retrieval is done on March 8, 2018, to compare with data before repair. Vibration data can be seen after repairmen for high speed and low speed bearings tend to improve.

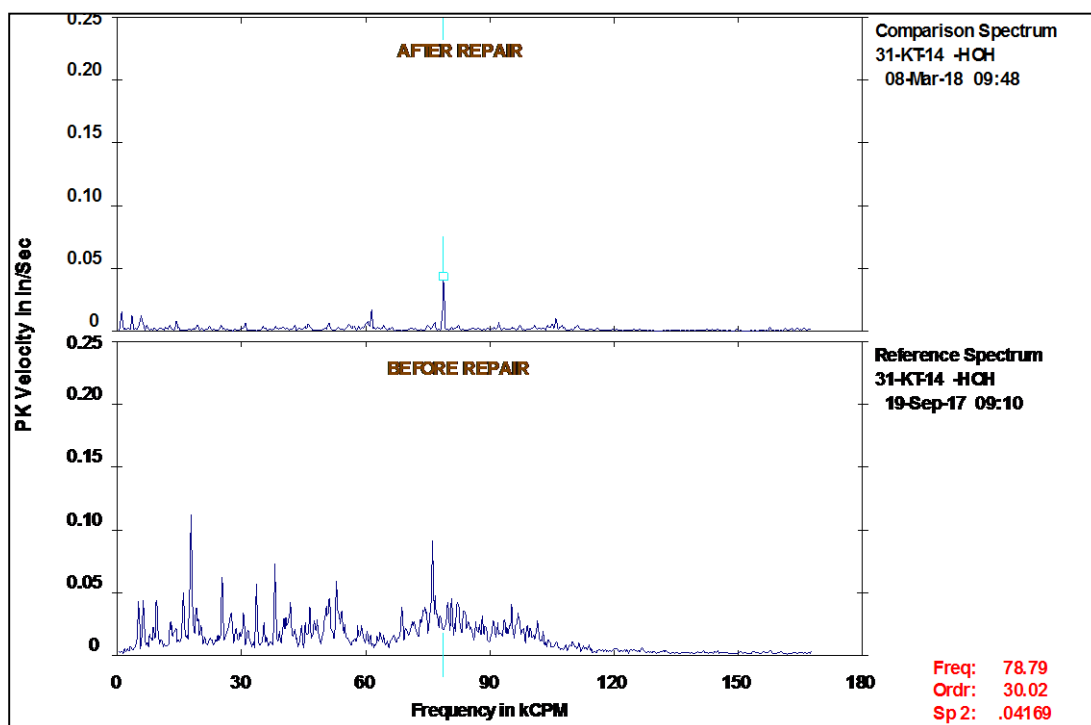
Figure 12. High Speed O/B Horizontal Spectrum Before and After Repair

Figure 12 shows the average spectrum of vibrations that occur in the gearbox before and after repair. It can be seen that before the repair there were many peaks which showed vibration in the gearbox, and after repairing it

appeared that the peak formed was much reduced.
