Compliance Assessment of an Existing Office Building with Updated Local Regulation in Jakarta

This study evaluated the compliance level of an existing office building in Jakarta, Head Office Building X, against the latest local regulation, Pergub DKI Jakarta No. 20/2024. This assessment was important for identifying compliance gaps in older buildings, since the building was constructed before the regulation came into effect. The regulatory provisions were interpreted qualitatively and translated into measurable indicators, which were validated using triangulation by reviewing available documents and validating them through on-site observations. The compliance checklist consisted of 24 indicators grouped into four categories: high-rise building provisions, accessibility, minimum infrastructure, and environmental requirements. Each indicator was assessed using three levels—compliant, partially compliant, and non-compliant—and converted into a 2/1/0 scoring system to produce a compliance matrix and category-level percentages. The results showed a total score of 14 out of 48 points (29.17%) The highest compliance was found in the high-rise building category (83.3%), while accessibilit

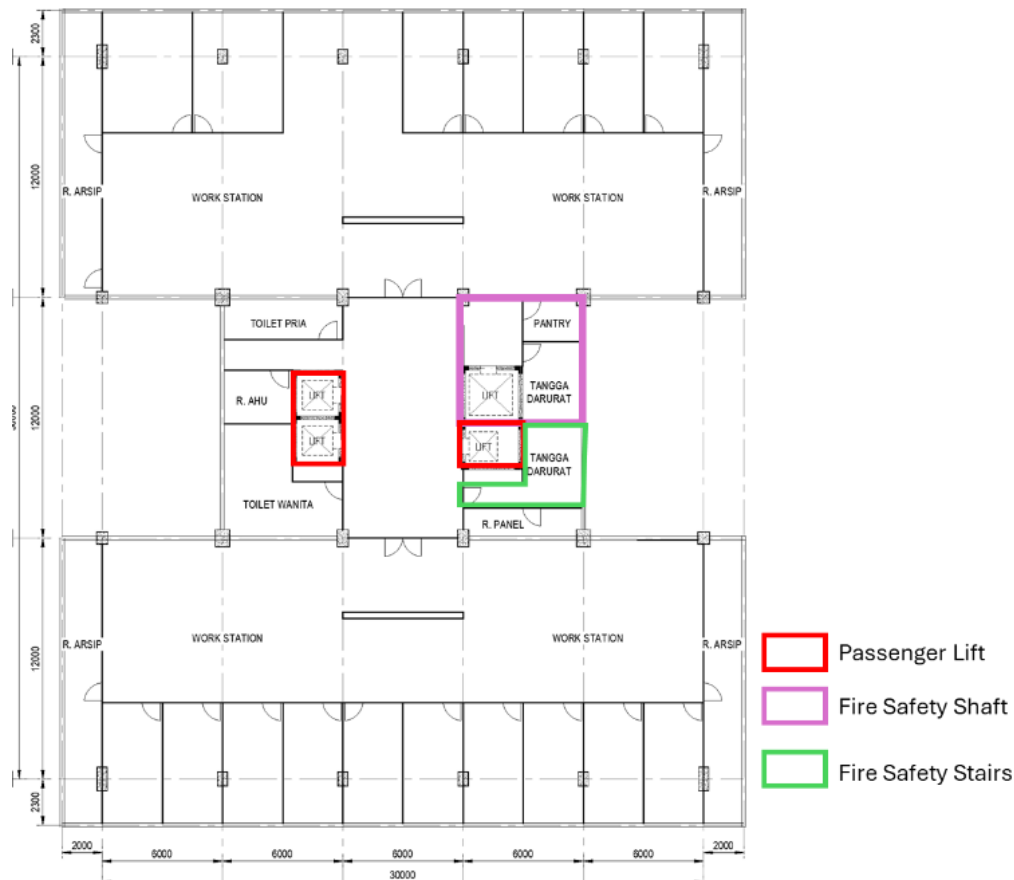
Figure 2. Existing conditions of fire man access and fire safety exit
(Source: Author, 2025)

In the high-rise building category, the compliance score was the highest at 83.3%. Head Office Building X has 10 floors, so it does not require a refuge floor. The building was also served by three passenger elevators and one service elevator. In addition, the building clearance exceeded the minimum requirement. However, the main concern lies in the lack of comprehensive aspects of life-safety. Because the floor area of Head Office Building X is more than 900 m², the regulation requires two fire safety shafts equipped with fireman lifts. Meanwhile, in the existing condition there was only one fire safety shaft equipped with a fire man lift. The fire-fighting lobby also still had double access to the pantry, and the building had only one emergency staircase, which was not equipped with a smoke-stop lobby (Figure 2).
