Building Information Modeling (BIM) as Tool to Develop Solution for Bridge Rehabilitation

Building Information Modeling (BIM) consists of processes that produce and handle information during the life cycle of a building. BIM may also be a technique involving the development and management of digital representations of a building or facility's physical and useful features. In 2D BIM software package programs, the paper explains the three-dimensional (3D) modeling of the project and the multidimensional (4D) modeling using another BIM viewer. Revit model is created based on primary data that visualizes the bridge. For analysis, dead load and moving load are considered. From the result analysis of the structure, an approach is provided to repair the Bridge using BIM. As per IRC: SP -40 (Guidelines for techniques for strengthening and rehabilitation of bridges). This paper is an attempt to build a model that could demonstrate the use of BIM for bridge rehabilitation.

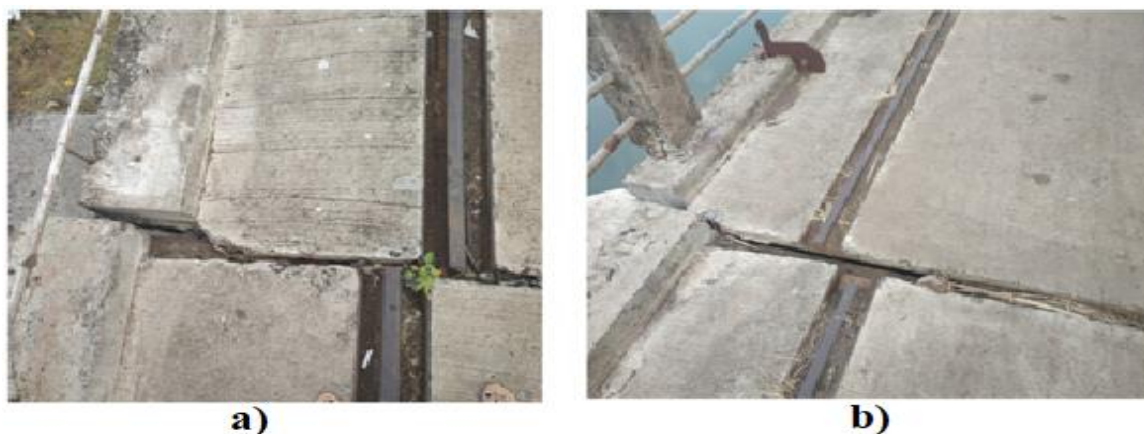
Figure 2. a) Displaced deck slab; b) Damaged expansion joint.

During the recent floods in August 2019, the deck slab has got disturbed because of the sudden surge of floodwater and excessive water pressure created due to vegetation and debris carries along with water. Due to flood 15 deck slabs except the first 3 on the left side and the last 1 on the right side of the bridge have moved downwards towards the stream. The Deck slab of the bridge got displaced **Figure 2a** shown in table **Table 1** and also wearing a coat of the joints has got damaged. The details are shown in **Figure 2b**.

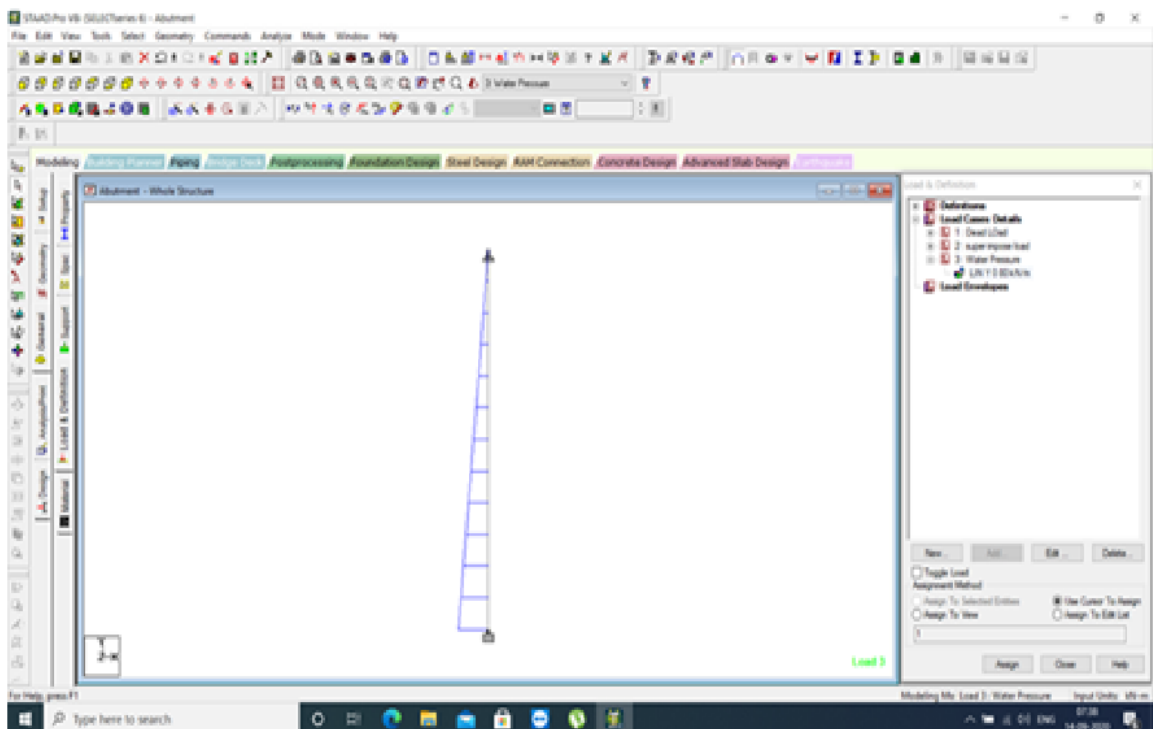
Figure 7. Horizontal forces due to water currents.

As per IRC:6- 2000 (Loads and stress) Clause No. 210 intensity of horizontal forces due to flood-water pressure is 10.18 kN/m^2 . Line model of bridge substructure as shown in **Figure 7** is prepared and analysis is done with and without water pressure.

After analysis, it can be observed that displacement in **Table 4** is increased by 20%. As per the Indian Road Congress (IRC), it is unsafe for use therefore, a rehabilitation solution is provided after analysis in section 3.4 to overcome the displacement of deck slab caused due to high water pressure.

Analysis of horizontal water pressure shows that displacement of deck slab with and without water pressure is increased by 20% and to overcome that displacement we need to provide an angle section to strengthen the deck slab.

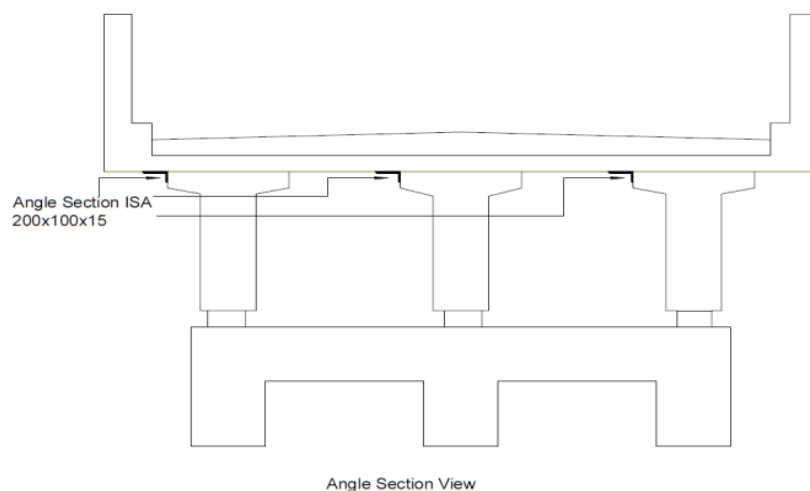
Figure 8. Angle section arrangement.

The solution is developed as a post-tensioning angle section in the longitudinal direction for the bridge deck slab and the T beam is shown in **Figure 8**. Each span provided three-angle sections.

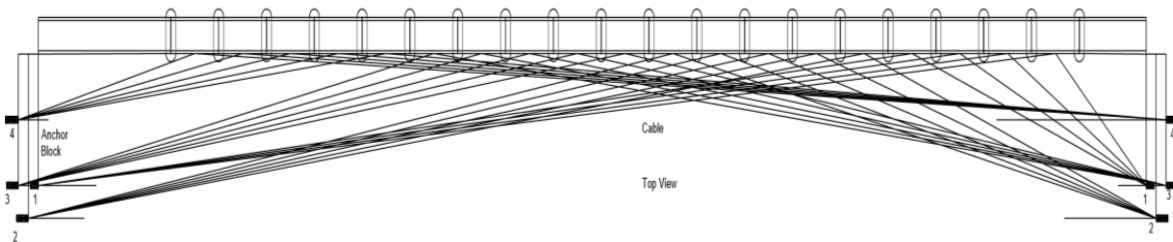
Figure 9. Cable with anchor block.

A cable is provided for the deck slab to withstand high water pressure refer to **Figure 9**. By resolving all the forces in the cable as per floodwater pressure of 10.18 kN/m² coming on deck slab, and by considering maximum tension in the cable the anchor block is designed for the structure as detailed in **Table 9**.

Design of Anchor block is done considering submerged soil condition having a unit weight of soil above the anchor block in **Table 10**.

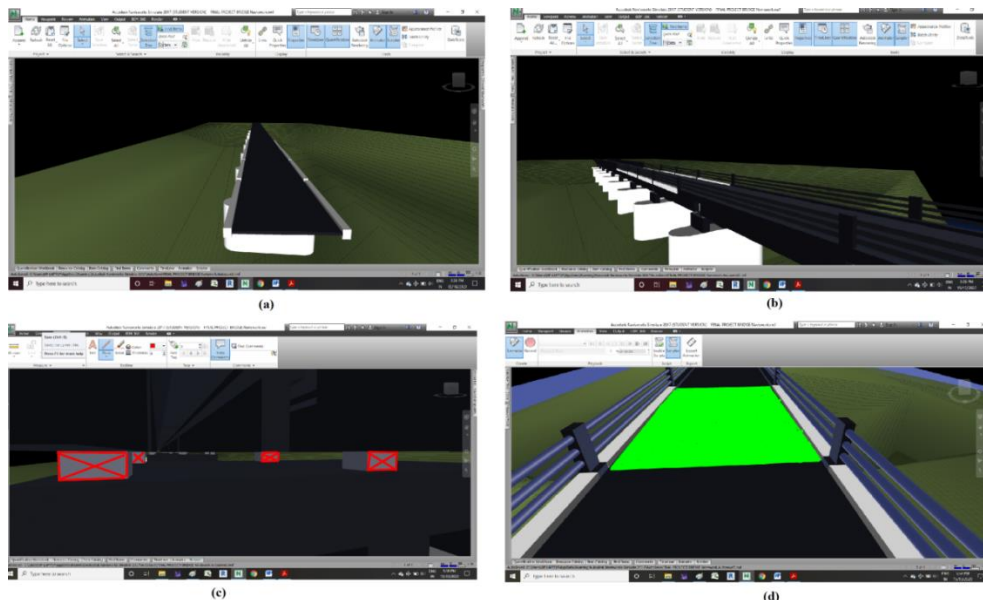
Figure 12. The 4D Model of construction phases.

The elements represented in red were the object of construction during the task, and the elements in green correspond to a removal or demolition process as part of the task. The simulation of the different tasks planned for the deck slab rehabilitation was obtained through the simulate tab of the *Timeline* command. **Figure 12** represents the construction phase (a) existing (displaced) deck slab; (b) reposition of deck slab and removal debris; (c) providing new bearing pads; (d) applying the wearing coat.
