Analysis of Facade Damage and Aesthetic Decline in Educational Buildings: A Case Study of Building C FPTI-UPI

^{1,2,3,4} Building Engineering Education, Faculty of Technology and Industry Education,
Universitas Pendidikan Indonesia, Bandung, Indonesia

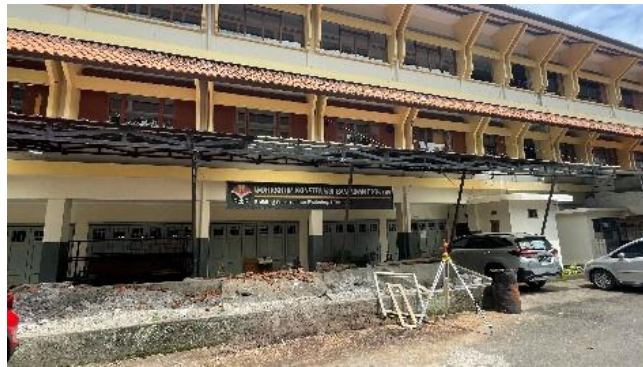
Figure 1. The Entire Facade of Building C FPTI-UPI

Figure 1 shows that Buildings are composed of various interrelated aspects that create function, strength, and beauty, resulting in strong, functional, and useful buildings for humans.

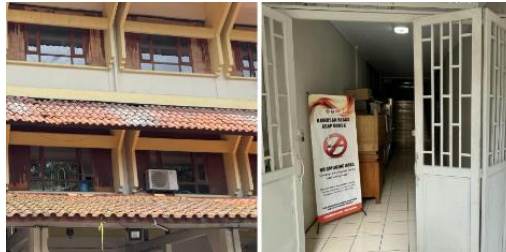
Figure 2. Building age damage

Damage that falls into the age category of a building includes the main door and window elements, which have experienced extensive damage, as seen in **Figure 2**. This is supported by research by Wardhana & Pontan (2022), which states that buildings that are 20 years old or older are more likely to experience damage to components, such as doors and windows, especially if they are not regularly maintained. This means that age-related damage cannot be prevented. However, the process can be slowed by performing regular building maintenance. Maintenance includes routine inspections, recording the condition of elements, and replacing components before they reach critical points.

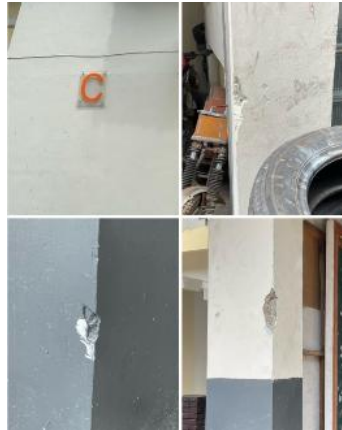
Figure 3. Human-caused damage

Human-caused factors account for the second-largest cause of damage, after the building's age, accounting for 37%. Damage categorized as human-caused includes scratches or graffiti on walls, damaged columns due to human activity, and so on, as evidenced by **figure 3**. In Building C, this human-caused damage was unavoidable because Building C, the FPTI-UPI, is the main building used for laboratory activities across various departments. This aligns with research by Wismantoro and Winarno (2024), which found that building damage is caused by a lack of routine maintenance and uncontrolled human activity, such as the use of buildings without regard for their original capacity and function.

The damaged facade, coupled with the disorganized arrangement of laboratory equipment, further diminishes the aesthetic value of Building C's facade. This situation highlights the importance of full awareness among Building C staff and users to mitigate existing damage. This is crucial to prevent further damage and ensure optimal maintenance of the facility (Utami and Saleh, 2022). The formation of this maintenance culture can reduce the percentage of damage caused by human activity and also create an orderly and ethical campus environment.

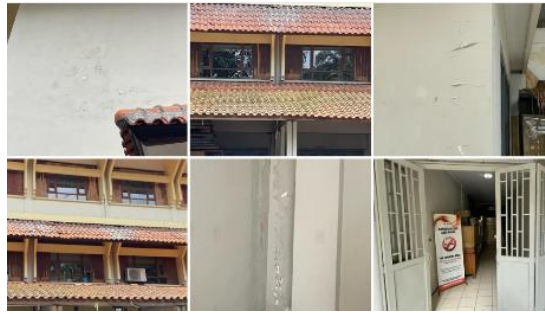
Figure 4. Environmental damage

Judging from the data in **Table 1**, the main cause of damage to the facade of Building C FPTI-UPI is from environmental factors with a contribution of 63%. From the observation data, it shows that the most striking damage is caused by the influence of the existing weather, such as rain and excessive heat, which causes weathering of elements in the openings, moss growth on the roof, weathering of the paint surface and others, as seen in **Figure 4**. This is reinforced by research by Daeli et al. (2025), factors that contribute to material degradation are high rainfall, strong winds, and excessive humidity, these factors affect the structural durability and aesthetics of the building. Environmental damage is a major challenge that must be continuously addressed. While environmental damage is unavoidable, it can be prevented by using materials that are resistant to extreme weather, proper ventilation and drainage, and regular maintenance. Without proper management, environmental damage will continue to erode the strength and aesthetic appeal of Building C FPTI-UPI.
