## Analysis of The Level of Acoustic in The Javanese Christian Church Bandung

Aulia Fauziah<sup>1\*</sup>, Rana Rafika Saptata<sup>2</sup>, Dwi Intan Azzura Purba<sup>3</sup>  
<sup>1,2,3</sup>Indonesian University of Education, Bandung, Indonesia

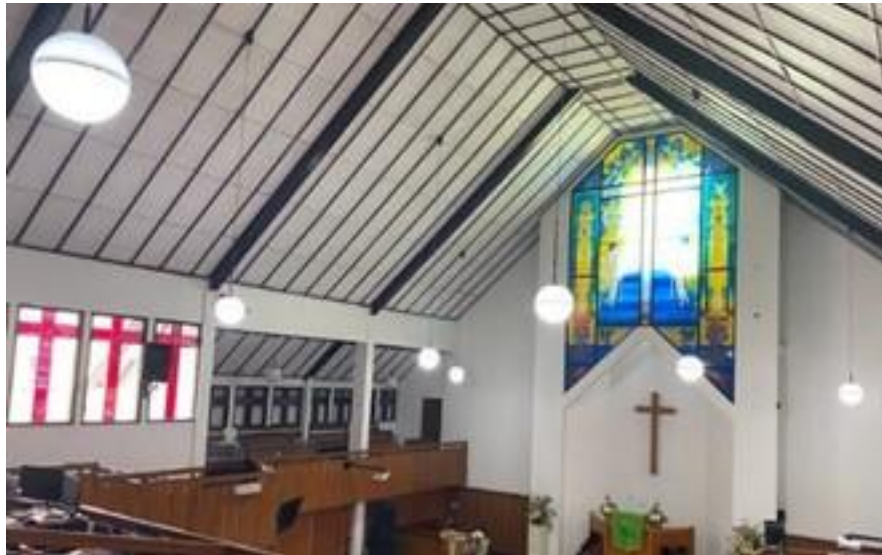
Figure 3. Inside of GKJ Bandung

- a) plastered brick wall
- b) ceramic-coated concrete slab floor
- c) combination ceiling of *gypsum*, wood, and iron
- d) wooden doors, wooden windows with stained glass
