## Architectural Criticism on Exterior Pavement Material Suitability of the Muhammad Cheng Hoo Mosque Jambi: A Universal Design and Accessibility Regulation Perspective

Lisa Maharani<sup>1</sup>, Merisa Rahma Mawaddah<sup>2\*</sup>

<sup>1,2</sup>University of Jambi, Indonesia

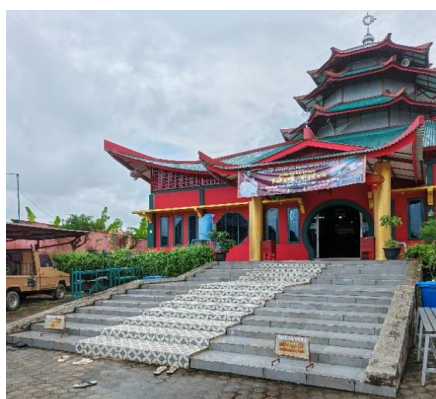
Four out of the five zones (A, B, C, D) utilize glazed materials with smooth and glossy surfaces. During observations conducted after rainfall, significant water ponding was observed in Zones B and C, while Zones A and D were uniformly wet. Zone D represents the most spatially critical point: it is here that users first remove their footwear and immediately step onto a potentially wet surface to descend the staircase in Zone A. Furthermore, no handrails on either side of the staircase, tactile paving guides, alternative ramps, or slippery floor warning signs were found across any of the observed areas.

Regarding the observed physical characteristics, all ceramic tiles in Zones A through D feature a glossy finish, indicating an absence of surface micro-texture. In technical literature, the lack of micro-texture means that the contact points between the floor surface and the sole of the foot are severely reduced when wet, drastically decreasing the friction effect I.-J. Kim (2024b). This condition is exacerbated in Zone A (staircase) due to gravitational forces that add downward momentum as users descend the steps, exponentially increasing the risk of slipping. From an Environment-Behavior perspective, this physical configuration directly conflicts with the ritual behavioral constraint of walking barefoot: users cannot avoid the unsafe surface, nor can they modify the ritual, the design bears full responsibility for mediating this conflict (Rapoport, 1980).

The following recommendations are formulated by simultaneously considering three aspects: user safety, compliance with accessibility regulations, and the continuity of the building's Sino-Islamic visual identity (Figure 3). For material replacement, each zone requires a different approach based on its level of water exposure and user conditions. Zone A (main staircase), which bears the highest risk due to direct rainfall exposure and mandatory barefoot use, should replace the existing polished granite with textured porcelain tiles or rough-finish natural stone such as andesite, both of which are classified in technical literature as appropriate for wet exterior staircases (DIN 51130). Step edges (nosing) should be fitted with dark-colored contrasting anti-slip strips to improve visual differentiation between steps. Material colors can be selected from the building's existing Sino-Islamic palette such as deep red or anthracite gray to maintain aesthetic continuity.

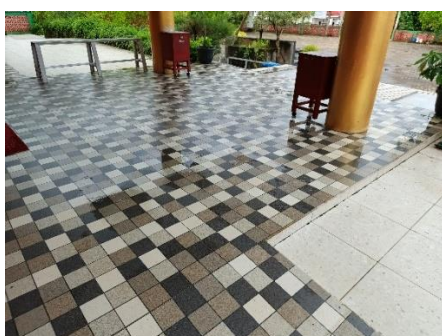
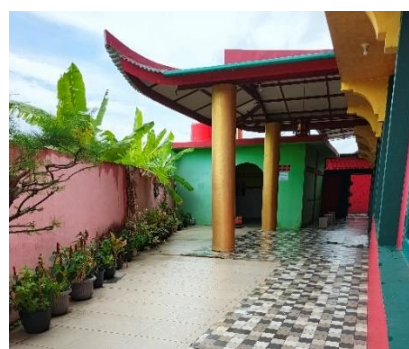
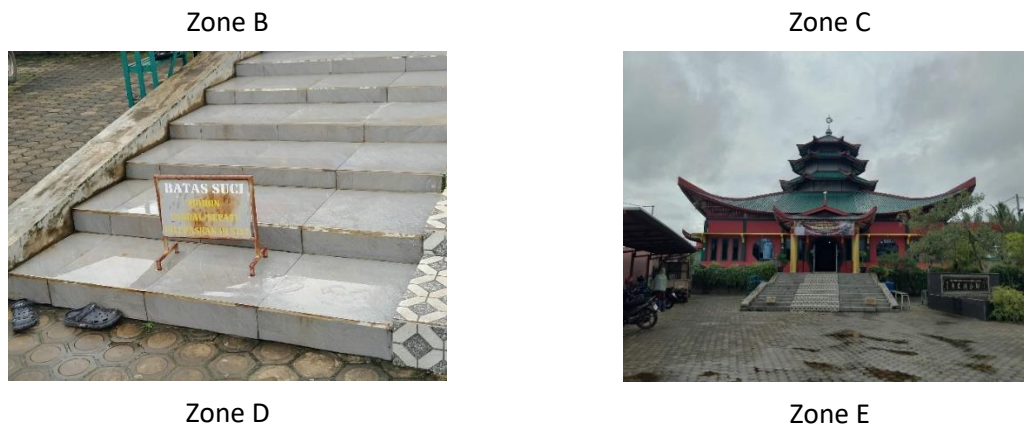
Figure 3. Observation Location Zone  
Source: Field Observation, 2026

Conversely, Zone E (hexagonal paving blocks) exhibits distinct conditions. Visually, the paving blocks possess a rougher surface texture and inter-block gaps that function as micro-drainage channels. These characteristics align with general literature recommendations for exterior pavement materials, although they still require periodic maintenance to prevent moss and algae growth.

traction while remaining comfortable on bare feet. Zone E (parking lot) requires no material replacement, as the existing hexagonal paving blocks already possess surface characteristics appropriate for exterior use; however, periodic maintenance is necessary to prevent moss and algae growth and to ensure inter-block joints remain clear for effective drainage.

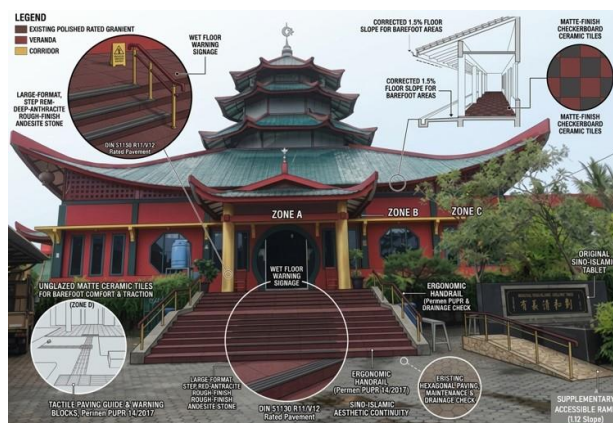
Figure 3 Design Recommendations

Zones B and C (roofed veranda and side corridor) should adopt matte or rustic-textured ceramic tiles in place of the existing glossy finish. The characteristic checkerboard pattern can be preserved through a two-tone matte tile combination, ensuring that the building's visual identity is maintained while substantially improving surface traction under wet conditions. Zone D (the *batas suci* transition area) demands the most careful material selection, as it is the point where users first make barefoot contact with the floor surface. Rough-finish andesite or unglazed ceramic tiles are recommended, as these materials provide adequate

Regarding the drainage system, Zones B and C must be retrofitted with a minimum floor slope of 1.5% directed toward edge gutters to prevent water ponding, a condition directly observed during post-rainfall field observations. Drainage channels should be cleaned regularly and fitted with flush covers to eliminate the secondary hazard of tripping.

With respect to accessibility elements required under Permen PUPR , (2017) No. 14/2017, three interventions are critical. First, handrails must be installed on both sides of the main staircase at a height of 85–90 cm from the step surface, using materials and finishes that harmonize with the building's existing architectural character. Second, tactile guiding paths, comprising both guiding blocks and warning blocks — should be installed along the primary circulation route from the parking lot to the building entrance, in accordance with the tactile paving requirements stipulated in Permen PUPR (Peraturan Menteri PUPR Tentang Persyaratan Kemudahan Bangunan Gedung, 2017) No. 14/2017. Third, an accessible ramp with a maximum slope of 1:12 should be constructed on the lateral side of the main staircase to accommodate wheelchair users and elderly visitors for whom stair negotiation presents a significant physical barrier. As a supplementary measure, wet floor warning signage should be placed at the *batas suci* boundary and at the top of the staircase, particularly during and after rainfall, to alert barefoot users before they step onto potentially hazardous surfaces.
