# Jurnal Arsitektur Zonasi

## Architectural Criticism On Exterior Pavement Material Suitability Of The Muhammad Cheng Hoo Mosque Jambi: A Universal Design And Accessibility Regulation Perspective

Lisa Maharani<sup>1</sup>, Merisa Rahma Mawaddah<sup>2\*</sup>

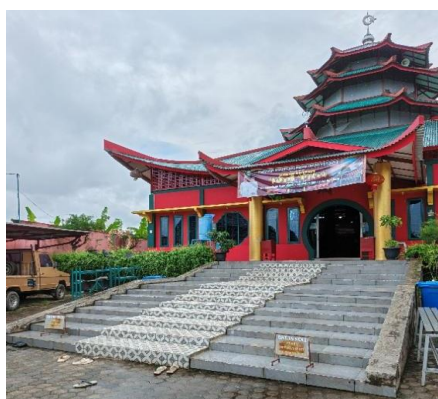
| Zone | Location | Existing Materials | Water Exposure | Footwear | Drainage |
|---|---|---|---|---|---|
| A | Main staircase | Polished granite/geometric patterned cemaric tiles | Directly exposed to rainfall | Removed ( <i>batas suci</i> ) | No visible drainage |

Four out of the five zones (A, B, C, D) utilize glazed materials with smooth and glossy surfaces. During observations conducted after rainfall, significant water ponding was observed in Zones B and C, while Zones A and D were uniformly wet. Zone D represents the most spatially critical point: it is here that users first remove their footwear and immediately step onto a potentially wet surface to descend the staircase in Zone A. Furthermore, no handrails on either side of the staircase, tactile paving guides, alternative ramps, or slippery floor warning signs were found across any of the observed areas.

Regarding the observed physical characteristics, all ceramic tiles in Zones A through D feature a glossy finish, indicating an absence of surface micro-texture. In technical literature, the lack of micro-texture means that the contact points between the floor surface and the sole of the foot are severely reduced when wet, drastically decreasing the friction effect I.-J. Kim (2024b). This condition is exacerbated in Zone A (staircase) due to gravitational forces that add downward momentum as users descend the steps, exponentially increasing the risk of slipping. From an Environment-Behavior perspective, this physical configuration directly conflicts with the ritual behavioral constraint of walking barefoot: users cannot avoid the unsafe surface, nor can they modify the ritual, the design bears full responsibility for mediating this conflict (Rapoport, 1980).

The following recommendations are formulated by simultaneously considering three aspects: user safety, compliance with accessibility regulations, and the continuity of the building's Sino-Islamic visual identity (Figure 3). For material replacement, each zone requires a different approach based on its level of water exposure and user conditions. Zone A (main staircase), which bears the highest risk due to direct rainfall exposure and mandatory barefoot use, should replace the existing polished granite with textured porcelain tiles or rough-finish natural stone such as andesite, both of which are classified in technical literature as appropriate for wet exterior staircases (DIN 51130). Step edges (nosing) should be fitted with dark-colored contrasting anti-slip strips to improve visual differentiation between steps. Material colors can be selected from the building's existing Sino-Islamic palette such as deep red or anthracite gray to maintain aesthetic continuity.

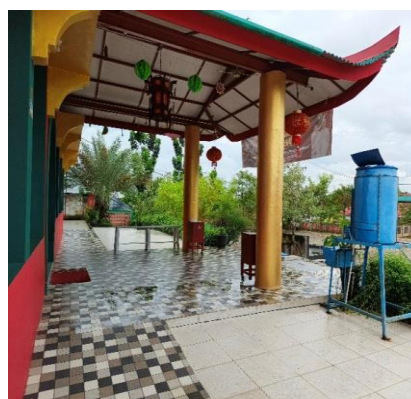
Zone B

| Zone | Location | Existing Materials | Water Exposure | Footwear | Drainage |
|---|---|---|---|---|---|
| B | Roofed veranda | Glossy checkerboard ceramic tiles | Semi outdoor, exposed to wind – driven rain/drips | Removed ( <i>batas suci</i> ) | Water ponding observed |

Zones B and C (roofed veranda and side corridor) should adopt matte or rustic-textured ceramic tiles in place of the existing glossy finish. The characteristic checkerboard pattern can be preserved through a two-tone matte tile combination, ensuring that the building's visual identity is maintained while substantially improving surface traction under wet conditions. Zone D (the *batas suci* transition area) demands the most careful material selection, as it is the point where users first make barefoot contact with the floor surface. Rough-finish andesite or unglazed ceramic tiles are recommended, as these materials provide adequate

Regarding the drainage system, Zones B and C must be retrofitted with a minimum floor slope of 1.5% directed toward edge gutters to prevent water ponding, a condition directly observed during post-rainfall field observations. Drainage channels should be cleaned regularly and fitted with flush covers to eliminate the secondary hazard of tripping.

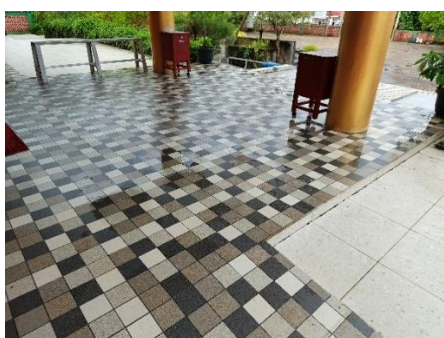
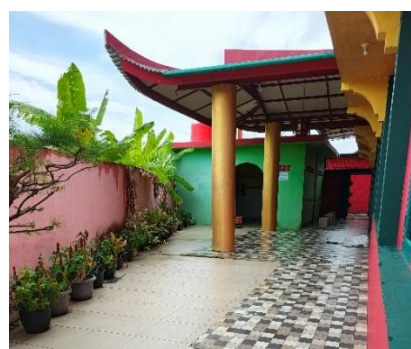
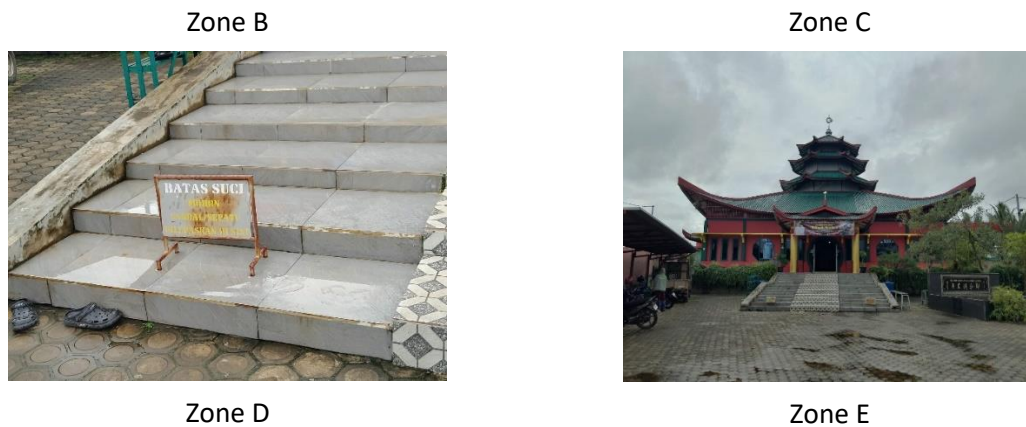
Figure 3. Observation Location Zone  
Source: Field Observation, 2026

Based on field observations, the exterior areas of the Muhammad Cheng Hoo Mosque Jambi are classified into five evaluation zones, each characterized by distinct material properties and exposure conditions. Table 1 and Figure 3 presents the identification of each zone.

Conversely, Zone E (hexagonal paving blocks) exhibits distinct conditions. Visually, the paving blocks possess a rougher surface texture and inter-block gaps that function as micro-drainage channels. These characteristics align with general literature recommendations for exterior pavement materials, although they still require periodic maintenance to prevent moss and algae growth.

traction while remaining comfortable on bare feet. Zone E (parking lot) requires no material replacement, as the existing hexagonal paving blocks already possess surface characteristics appropriate for exterior use; however, periodic maintenance is necessary to prevent moss and algae growth and to ensure inter-block joints remain clear for effective drainage.
