# Jurnal Arsitektur Zonasi

## Redesign of the Pulantara Landscape at Kanoman Palace Based on Vegetation Analysis

Sabrina Amalia<sup>1\*</sup>, Reza Phalevi Sihombing<sup>2</sup>

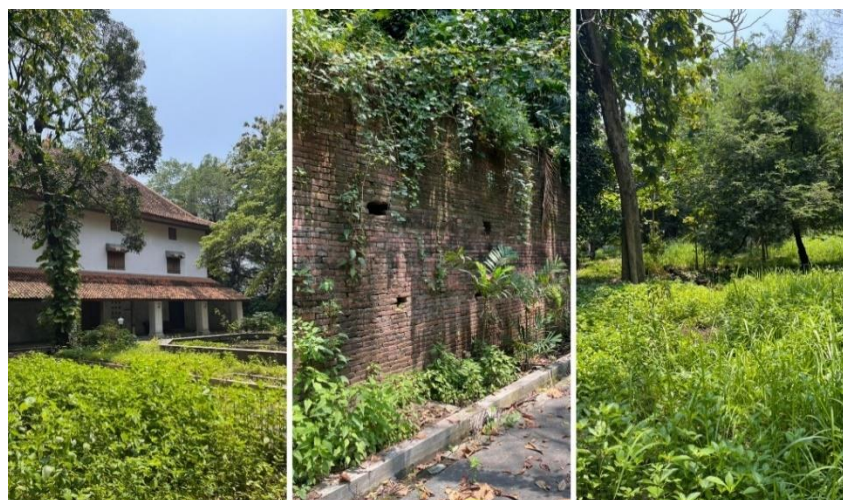
Figure 2. Existing Landscape Condition of Pulantara, Kanoman Palace  
(Source: Personal Documentation, 2026)

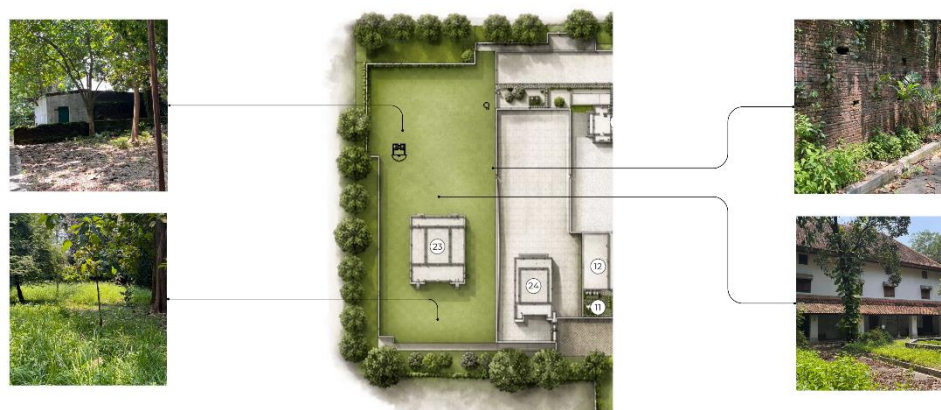
Figure 3. Existing Condition of Pulantara, Kanoman Palace  
(Source: Personal Documentation, 2026)

The existing condition indicates that vegetation is one of the dominant elements in the Pulantara area. Vegetation functions as a shade provider and space-forming element; however, several areas show irregular vegetation growth and relatively dense understory vegetation. The structure and composition of vegetation within a site can be influenced by environmental conditions and vegetation growth processes (Wijaya et al., 2021). These conditions cause several areas to appear less organized and require maintenance and arrangement according to their spatial functions. Vegetation in good condition continues to contribute to spatial quality and should therefore be considered in the redesign process. Meanwhile, irregularly growing vegetation requires further analysis to determine appropriate management actions. Vegetation arrangement should consider plant species, condition, function, and suitability to spatial requirements in order to support landscape quality.

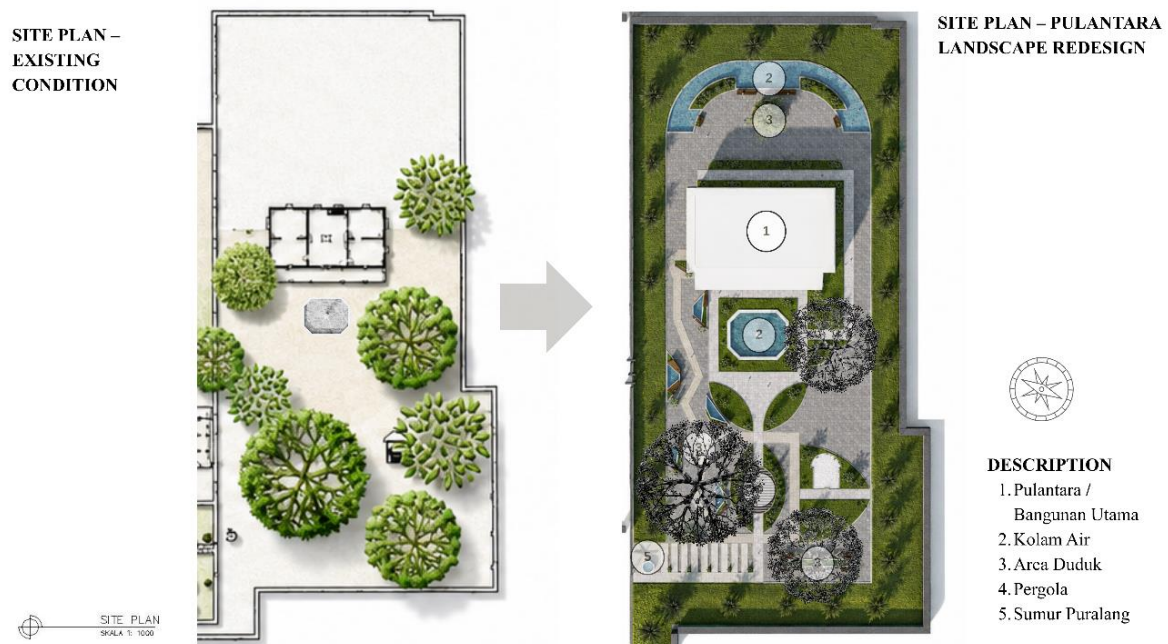
Figure 10. Comparison of Existing and Redesigned Site Plans  
(Source: Author's Documentation, 2026)

Vegetation with good conditions and functions was retained, vegetation considered less suitable was reorganized, vegetation interfering with spatial functions was selectively reduced, and new vegetation was added in areas requiring improved functions. The *research-by-design* approach enables analysis results to be translated into design decisions through the design process. In landscape architecture, design can serve as a research strategy for generating knowledge through analysis and design development (Nijhuis & Vries, 2015). Thus, the redesign of Pulantara represents a synthesis between existing vegetation conditions and spatial development requirements.

The redesign retains vegetation structures that continue to provide functions and adapts new landscape elements to the existing conditions. Pedestrian paths, seating areas, open spaces, pergolas, and other supporting elements are positioned by considering existing vegetation so that changes to the existing landscape can be controlled. The final design, presented through the site plan and design visualizations, demonstrates the application of vegetation management guidelines to the spatial structure of Pulantara.

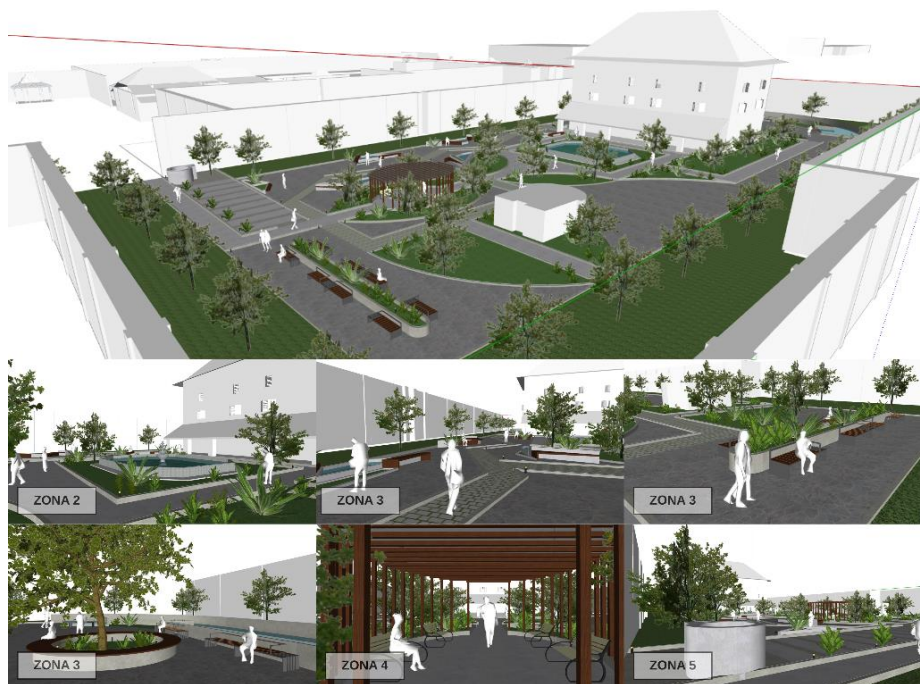
Figure 11. Perspective of the Landscape Redesign of Pulantara, Kanoman Palace  
(Source: Author's Documentation, 2026)
