# Jurnal Arsitektur Zonasi

## Natural Lighting Performance in the Service Room of a Three-Story Office Building in West Bandung Regency

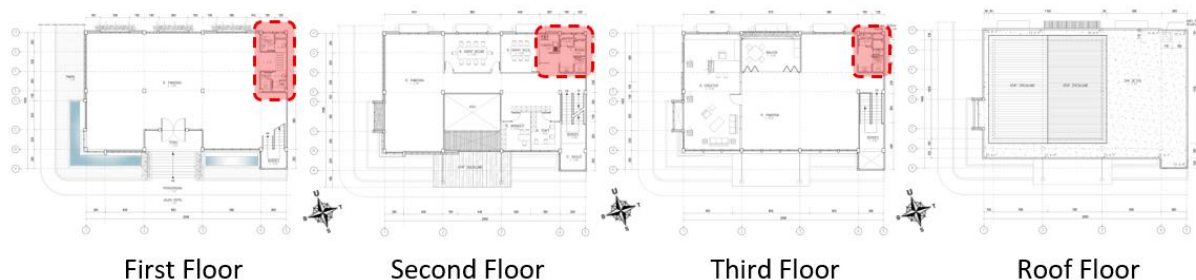
Figure 2. Research Object Layout

The object of the study was an office building with a height of 3.5 floors and a total floor area of 1,024.4 m<sup>2</sup>. This building serves as an operational office and a fabric product exhibition hall. The first floor, covering an area of 288.5 m<sup>2</sup>, is used as an exhibition hall, lobby, entrance area, and supporting facilities such as toilets and janitor's room. The second floor, with an area of 286.4 m<sup>2</sup>, accommodates additional exhibition space, large and small meeting rooms, manager's office, staff room, prayer room, pantry, and service room. The third floor, covering an area of 279.2 m<sup>2</sup>, is used as the director's office, exhibition hall, balcony area, and service facilities, while the roof floor, covering an area of 170.3 m<sup>2</sup>, is used as a utility room and roof area of the building.

First Floor

Second Floor

Third Floor

Roof Floor
