Jurnal Arsitektur Zonasi

Evaluation of Facilities and Infrastructure of Bandung Station as a Circulation HUB for the North-South Region

Adam Juan Kevin Rinaldy *[1], *Yohanes Basuki Dwisusanto* [2]

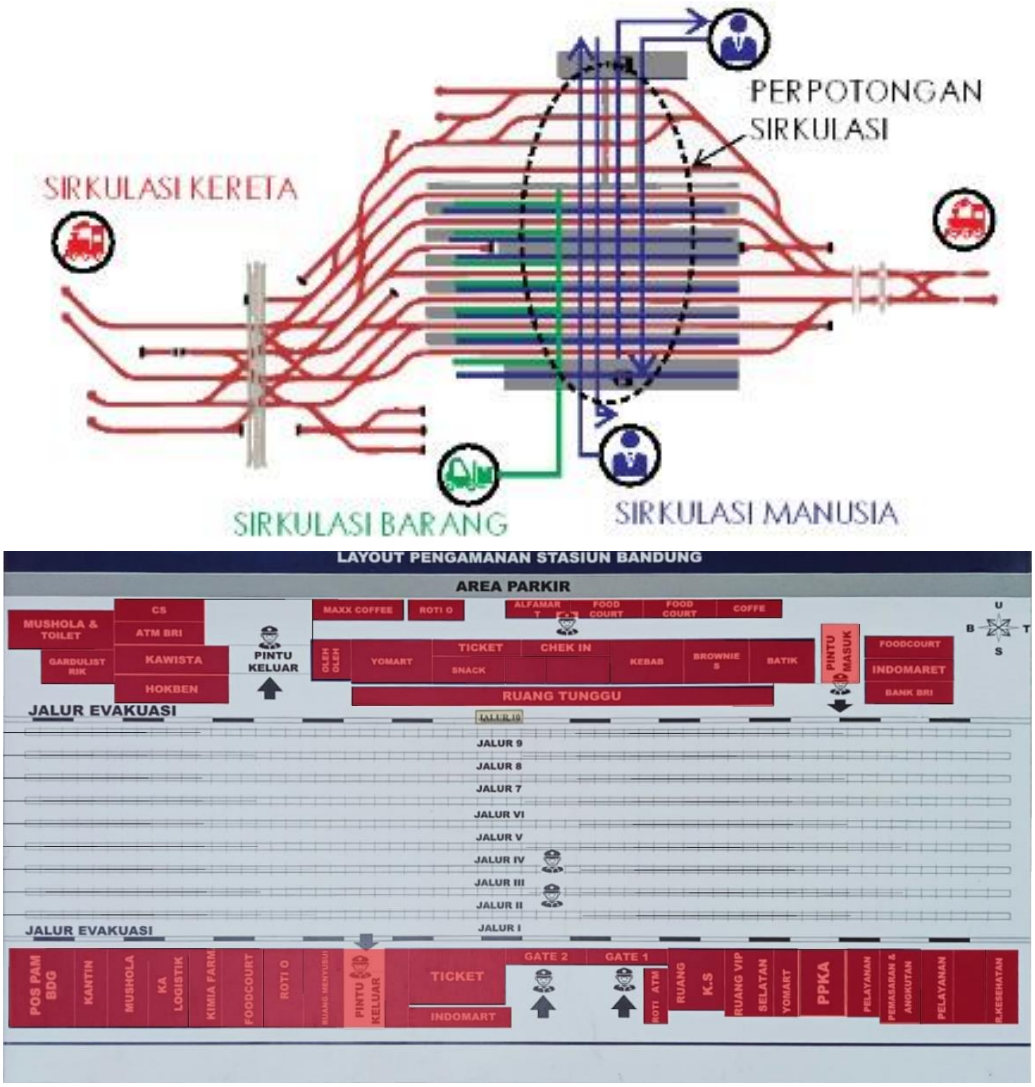
Figure 3. Problem Analysis in Interior Space (Floor Plan)
(Source: Author's analysis, 2025)

This section describes the Bandung Hall Station site in detail between the north station building and the south station and also finds several major problems, including the following: There are many intersections of human and train circulation in the rail and platform areas. Lack of facilities for waiting for trains in the south station building. The condition of the South Station, especially on Jalan Stasiun Barat, is not well organized, the condition of the North Station, especially the entrance area, is not well organized and there are many public transportations that cause congestion in access especially on Peron area.

Problem	Information
Intersection of human and train circulation	Occurs in the rail and platform areas
Lack of waiting facilities in the south building	Lack of waiting facilities in the south building Lack of comfortable waiting areas
South Station area (Jl. Stasiun Barat) is not well organized	South Station area (Jl. Stasiun Barat) is poorly organized Spatial planning and facilities are inadequate
North Station area is not well organized and is disturbed by public transportation	North Station area is not organized and is disturbed by public transportation Causes congestion in access to the station

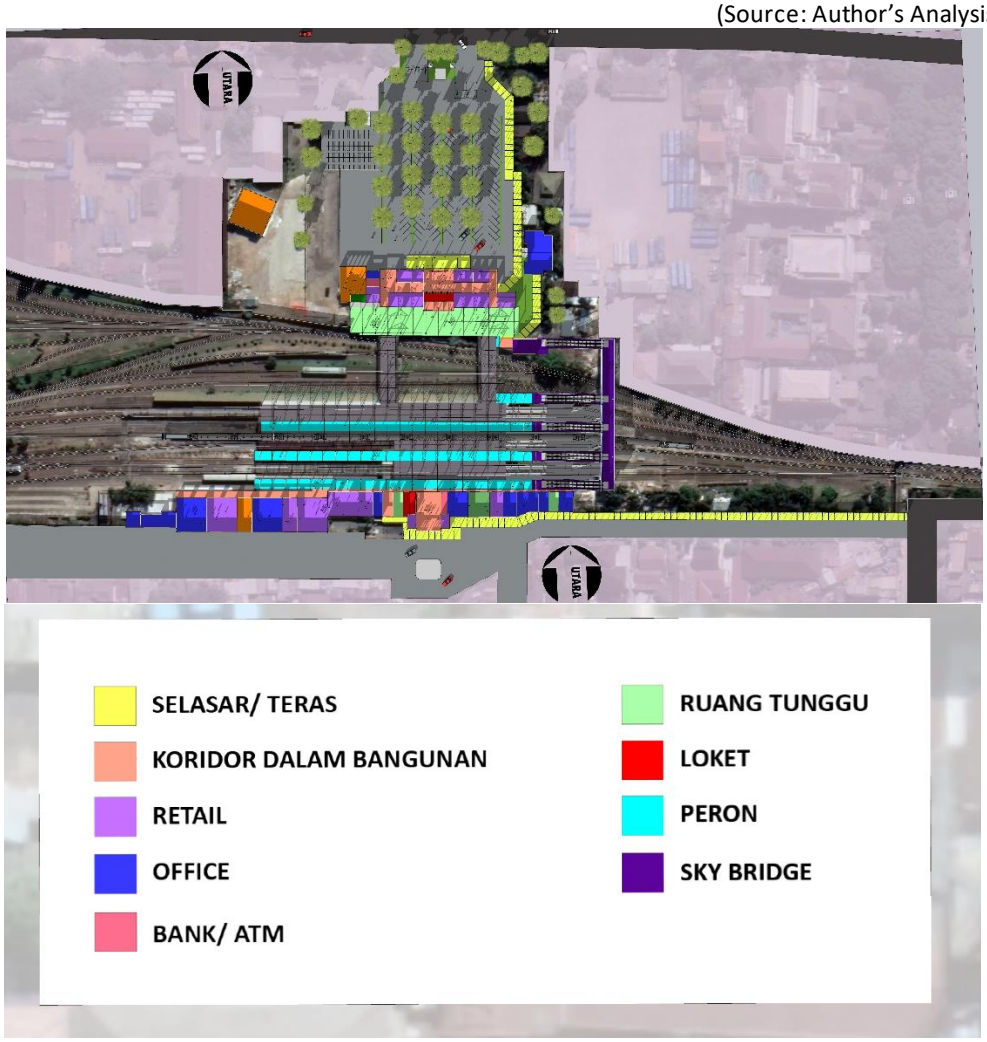
Figure 4. Existing Space Zoning Analysis
(Source: Author, 2025)

- Major Problem: A significant issue with the existing zoning is the restricted access system, which limits entry only to ticketed passengers. This creates a physical and social barrier between the northern and southern parts of the station, reducing pedestrian connectivity and interaction with the surrounding urban environment. As a result, the station fails to function effectively as an integrated public space, diminishing its role as a vibrant urban hub.

- Minor Problem: Within passenger zones, some waiting and circulation areas are inadequately sized or poorly arranged, causing congestion during peak hours. The flow between ticket counters, waiting rooms, and platforms lacks smooth transitions, leading to bottlenecks and discomfort for users.

- Opportunities for Improvement: Improving spatial zoning by introducing more inclusive access policies and redesigning pedestrian pathways can enhance

connectivity and user comfort. Expanding and reorganizing waiting and circulation spaces will better accommodate passenger volumes and improve overall station efficiency.

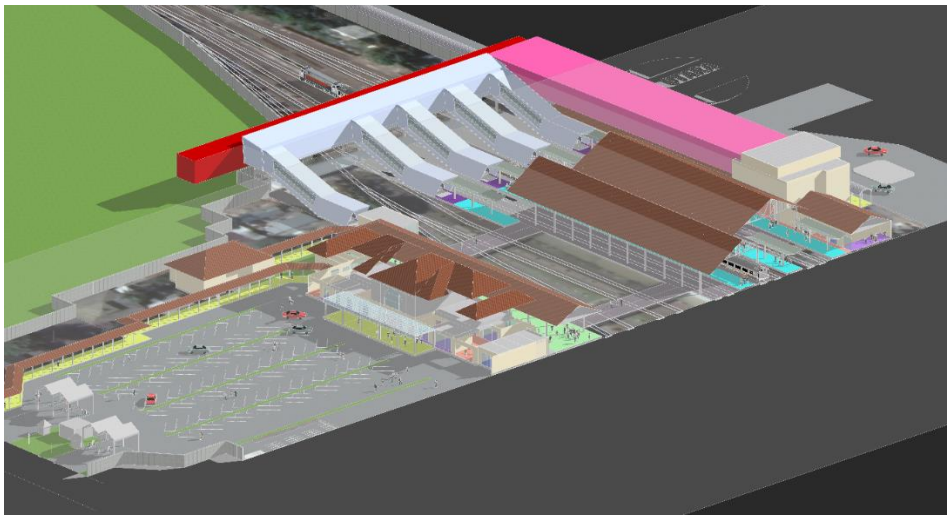
Figure 7. The Atmosphere Skybridge In Bandung Station
(Source: Author's Analysis, 2025)

The skybridge at Bandung Station was originally designed to serve as a pedestrian connector between the northern and southern parts of the station, improving circulation and allowing easier movement across the rail tracks. It aimed to enhance passenger flow, reduce crossing at track level, and support integration within the station complex by providing a safer, elevated pathway. However, in practice, the skybridge has not fully addressed the circulation challenges for several reasons:

1. **Access Limitation**: The skybridge is restricted to ticketed passengers only, which excludes pedestrians, visitors, or local residents who may want to cross from one side of the city to the other via the station. This undermines the idea of the station being an inclusive public connector.
2. **Unresolved Circulation Conflict:** There is still a crossing of flows between arrival and departure passengers, especially near the platform areas and access gates. The layout and routing do not effectively separate or organize these movements, leading to congestion and confusion, particularly during peak hours.

Aspect	Before Skybridge	After Skybridge	The problem that still occur
Accessibility	Passengers move between platforms via underpasses, making it difficult for people with disabilities and the elderly.	Skybridges make it easier for ticket holders to move between platforms.	Access to the skybridge is for ticket holders only, limiting access for non-passenger visitors, which is not in line with the principle of inclusiveness of public space.
Passenger Circulation	Separate arrival and departure flows, but with inadequate facilities.	More efficient circulation for ticket holders.	Only one skybridge causes arrival and departure flows to mix, causing congestion during peak seasons.
Non-Ticket Visitor Access	Visitors can access the platform area freely.	Access is limited, non-ticket visitors must detour through the outer area of the station such as Paskal and Kebon Jati.	Longer and inefficient travel distance for non-ticket visitors, making it difficult especially for the elderly and people with disabilities

1. Addition of Skybridge or Alternative Route
2. Build additional skybridge or alternative route to separate arrival and departure routes, reducing congestion during peak seasons.
3. Accessibility Improvement
4. Open skybridge access for non-ticket visitors with adequate supervision, and provide facilities such as lifts and ramps in accordance with PM 98 of 2017.
5. Station Layout Evaluation
6. Conduct a comprehensive evaluation of the station layout to ensure that all areas support the principles of inclusivity and efficiency.
7. Provision of Clear Information
8. Provide clear and easily accessible information regarding circulation routes and available facilities, assisting passengers and visitors in planning their trips.
