Bearing Failure Analysis on Gearbox Forced Draft Fan at LNG Plant

Boilers Forced Draft Fan has a gearbox reducer to reduce speed from steam turbine as a driver and fan as the driven. Based on Predictive Maintenance Group at Machinery and Heavy Equipment Section, it was found that gearbox has high vibration and noise when boilers load on 195 Ton/Hr (Max Load 295 Ton/hr). Vibration Analysis indicates that the source of vibration comes from bearings with peak value 0.572 in/sec at gearbox high speed outboard vertical and 0.593 in/sec at gearbox high speed outboard horizontal (Max Allowance 0.50 in/sec). Lubrication analysis using X-ray Fluorescence method, to see wear particle on lubricating oil showed that Tin(Sn) content is very high 203.62 mg/L (maximum allowance for Tin(Sn) at gearbox is 20mg/L), but wear debris are not found in lubricating oil. Gearbox disassembly found that high speed and low speed bearings suffered severe corrosion. Corrosion at bearings are caused by water contamination on lubrication oil, it comes from steam leak due to carbon ring failure at steam turbine, which is steam turbine bearing lubrication and gearbox lubrication get into one lubrication system. Af

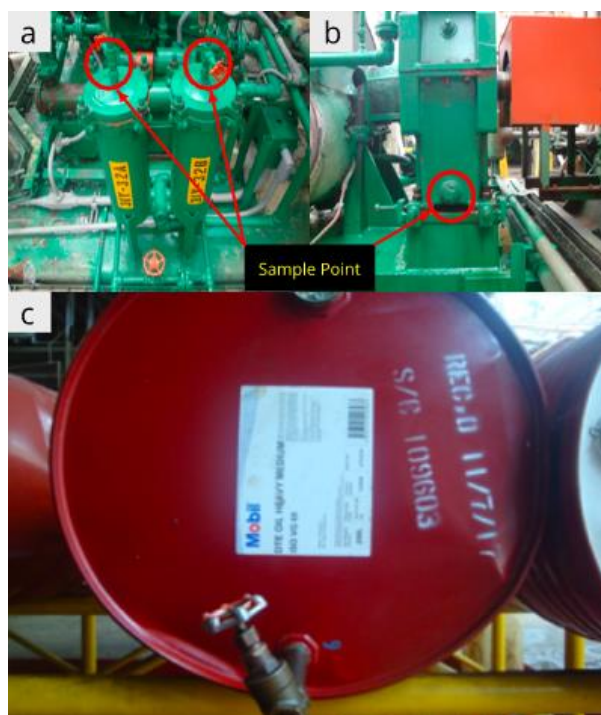
Figure 4. Lube Oil Filter (a) Gearbox Drain (b) and lubricants used for gearboxes (c)

Lubrication analysis is done by taking the lubricant sample on the gearbox to be tested for water content, metal debris, and metal particle. Figures 4a and b show the position where the sample was taken. Filtration method is carried out to find out if there are metal flakes in the lubrication system with a visible size, if there is one then it is certain that the components in the gearbox have suf-

Visual examination of the failed bearings revealed that it suffered severe corrosion. **Figure 6** shows bearings location inside gearbox housing. The condition of bearing is covered by sludge, this sludge is formed because of the mixture of water and oil inside gearbox housing. And **Figure 4** shows the remaining water deposits in the bottom of the gearbox housing. This indicates that there has been contamination of water in the lubricant system.
