Journal of Architectural Research and Education

A Study on The Implementation of Inclusive Open Spaces: Case Study of Odah Bekesah Park Samarinda

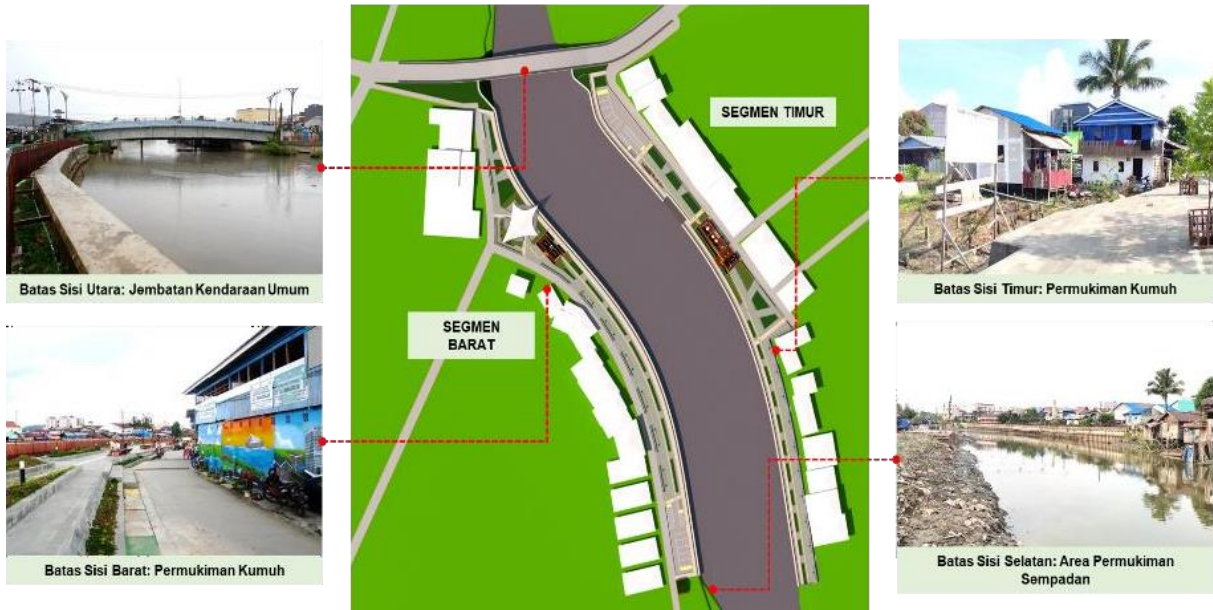
Figure 1 Spatial Configuration and Orientation
(Source: Analysis, 2023)

Odah Bekesah Park based on the spatial configuration is surrounded by a slum area which is quite strategically located in the city center. The ones that directly border the park are slum housing on the west and east sides, the river border area on the south side, and the bridge/vehicle lane on the north side.

Identifikasi Fisik Lingkungan Taman Odah Bekesah (Konfigurasi Ruang & Orientasi)

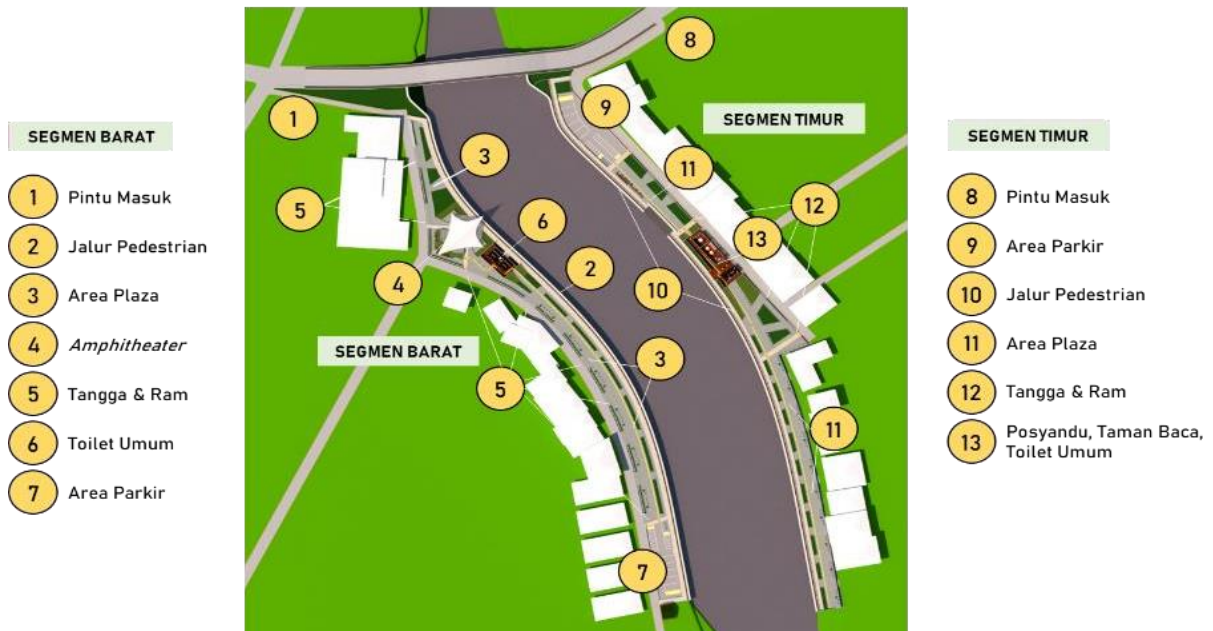
Figure 2 Existing Conditions
(Source: Analysis, 2023)

Odah Bekesah Park can be divided into 2 (two) segments, namely the west segment and the east segment which stretch linearly along 450 m. The area of the park is 4,250 m². In the west segment, the existing elements analyzed consist of the entrance, pedestrian path, plaza area, amphitheater, stairs and ramps, public toilets, and parking area. In the east segment, the existing elements analyzed consist of the entrance, parking area, pedestrian path, plaza area, stairs and ramps, and integrated buildings (posyandu, reading park, and public toilets).

Identifikasi Fisik Lingkungan Taman Odah Bekesah (Kondisi Eksisting)

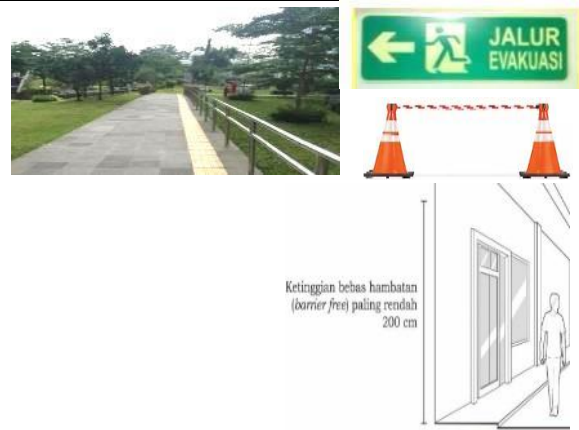
Table 3 West Segment Pedestrian Path

The pedestrian path consists of hard material/pavement in the form of non-slip terrazzo tiles. There is a 90 cm high handrail with square hollow material on the left side. On the right side there is a planter box containing shrub vegetation and groundcover in the form of grass as a soft material element that limits the pedestrian area with other open areas. Furnishing elements along this path that are found are garden lights and signs prohibiting throwing objects into the river. The width of the pedestrian path is 120 cm. Problems found in photo (A): the handrail is used as a drying area by the surrounding community and there is a planter box shape with sharp corners. In photo (B): the iron/supporting poles of the membrane roof in the amphitheater area are sloping, the height is not significant ($\pm 1.75 - 1.80$ cm right on the axis of the pedestrian path). In photo (C): there is no guide path, no directional signs and evacuation routes and construction/repair work was found Which No equipped APK (Tool Occupational Safety and Health) as standard in construction K3.

In accordance with the technical provisions in PUPR Ministerial Regulation No. 14 of 2017, there must be a guideway (direction and warning) for people with disabilities. The minimum barrier-free height is 200 cm. In addition, signs and markings are needed to indicate directions and evacuation routes. For the safety of users of public facilities, in construction work according to PUPR Regulation No. 10 of 2021, K3 APK instruments must be equipped such as safety fences/project area boundaries.

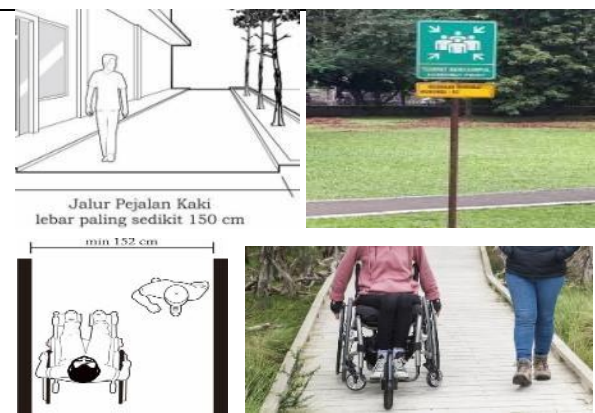
Table 4 West Segment Plaza Area

The plaza area consists of hard material/pavement in the form of non-slippery burnt andesite natural stone and planter boxes containing shrub vegetation and groundcover in the form of grass as soft material elements. Furnishing elements in this area that are found are park benches, park lights, and 3R trash bins. The area of the plaza varies and there are guide paths. Problems found in photo (A): the difference in height/level between the park pavement area and the planter area without being limited by curbs/curbstones. In addition, because the park is close to a slum area, people are not orderly in placing vehicles, carts, and places to dry clothes. In photo (B): the difference in height/level between the park pavement area and the planter area without being limited by curbs/curbstones. There is also a free access distance of less than 90 cm so that it cannot be passed by wheelchair users. In photo (C): the placement of community belongings that are not in their place, blocking the trash bin environment. On Photo (D): there is form planter box which the corners sharp.

In accordance with the technical provisions in PUPR Ministerial Regulation No. 14 of 2017, the minimum distance between pedestrian and wheelchair paths is 150 cm. In addition, signs and markings are required to indicate directions and evacuation routes as well as muster points for the plaza area. The installation of curbs serves as markers and edge guards between circulation/access areas and other functions such as planter boxes/parking areas/descents that are quite high. Based on the NDA reference, the maximum height of the trash bin is 130 cm with a contrasting color ("Building for Everyone: A Universal Design Approach, Center for Excellence in Universal Design," 2012).

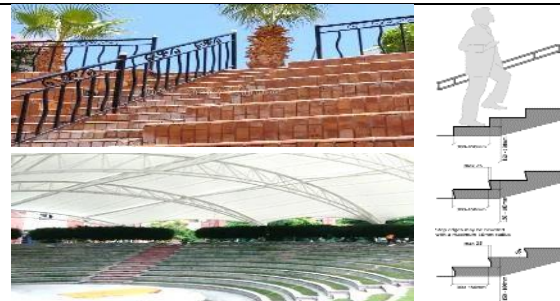
Table 5 West Segment Amphitheater

Area amphitheater consists of on material/pavement in the form of bunt andesite natural stonenon-slippery, planter boxes containing shrub vegetation and groundcover in the form of grass as soft material elements, and membrane roof structures that protect from heat and rain in the grandstand area. Problems found in photo (A): in the grandstand area, there is no standard hand railing. The height of the grandstand area is 280 cm from the ground floor, so there needs to be a safety fence. In photo (B): the membrane roof does not completely cover the grandstand area, so it is less than optimal in providing shade for grandstand area users. In photo (C): there are

Apart from that, there is a planter box shape that has sharp corners. And No friendly to user child-child/disabled person disability.

In accordance with the technical provisions in PUPR Ministerial Regulation No. 14 of 2017, there needs to be a guide path (direction and warning) for people with disabilities, as well as safety fences in areas that are quite high. In addition, signs and markings are needed to indicate directions and evacuation routes. This area is also suitable if used as a muster point because it is quite large. Based on reference NDA, more Good If

Step nosing was added to the grandstand stairs area, so that it doesn't slip/be slippery when stepping.

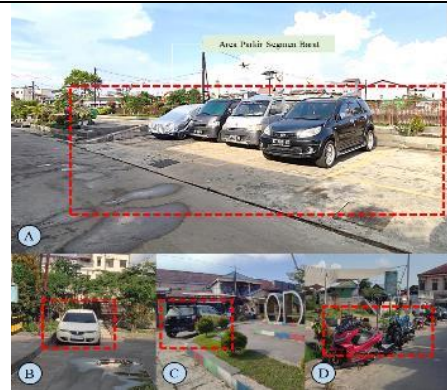
Table 8 West Segment Parking Area

The parking area in the western segment is next to the plaza area with a parking area of 175 m². The parking available is for 4-wheeled and 2-wheeled vehicles, where the pavement in the parking area is concrete/rigid concrete. The problem found in photo (A): based on the marking line, the placement of 2-wheeled parking is filled by 4-wheeled vehicles. For 4-wheeled parking, it is more dominated by vehicle owners from the community who live around the park area, so that visitors do not get parking access. Then, there are no parking facilities for people with disabilities. As it should be, parking for the disabled is on the side that is close/next to/not far from the ramp access. There are no bicycle parking facilities equipped with bicycle racks. In photos (B), (C), and (D): vehicles from people who live around the park area that are parked, take up the width of the road only 3-4 m. So that circulation vehicle on road environment the disturbed And Nooptimal.

According to the technical provisions in PUPR Regulation No. 14 of 2017 and NDA references, parking of 4 or 2-wheeled vehicles must facilitate the needs of the disabled. The standard for 4-wheeled parking is vertical/horizontal (not diagonal) with a width of 2.4-3.6 m and a length of 4.8-7 m. There is free space to maneuver a wheelchair with a minimum width of 120 cm. The number of disabled parking needs is adjusted to the number of disabled people identified in the sub-district/district area. Paving in the parking area, free from gaps/holes, with clear markings/contrasting colors. For 2-wheeled vehicles, the minimum parking area is 0.7x2 m. There is a bicycle parking area with parking dimensions of 0.8x1.2 m.

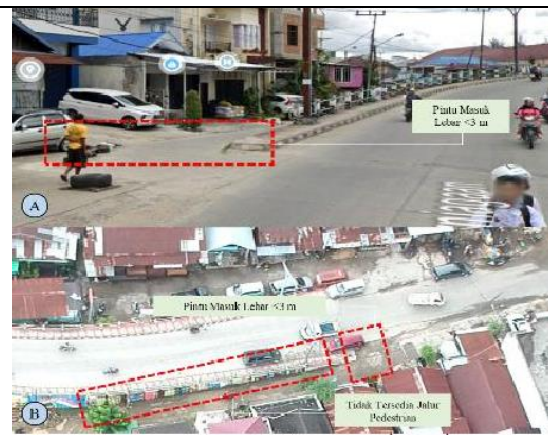
Table 9 East Segment Entrances

The existing condition of the entrance gate on the eastern segment is also faced with the problem of land provision. The hard material elements are rigid concrete roads for 2 and 4 wheeled vehicles, and closed drainage that flows into the river bank. The problems found in photo (A): the entrance gate is only 2.6 m wide with a turning radius at the entrance area attached to the side of the pedestrian bridge abutment so that 4 wheeled users must take turns so that can enter to area park. OnPhoto (B) After passing through the entrance, there is no pedestrian access. At the end of the road towards park, corner bend broken without There isradius minimum For maneuver vehicle wheel4.

According to the technical provisions of SNI 03-1733-2004, the minimum road width in residential areas/secondary local roads III is 3 m (2 and 4 wheels), the road shoulder for emergency parking is 0.5 m, and pedestrians are 1.2 m. Meanwhile, for radius obstacle tum in accordancep r o v i s i o n PUPR Regulation No. 14 of 2017, for roads with a width of 3 m, namely 8.84 m.

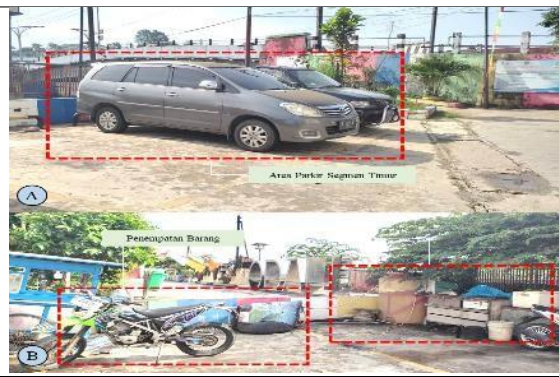
Table 10 East Segment Parking Area

The parking area in the eastern segment is next to the plaza area with a parking area of 234 m². Parking that is available for 4-wheeled and 2-wheeled vehicles, where the pavement in the parking area is concrete/rigid concrete. The problem found in photo (A): 4-wheeled and 2-wheeled parking is dominated by vehicle owners from the community living around the park area, so that visitors do not get parking access. Then, there are no parking facilities for people with disabilities. As it should be, parking for the disabled is on the side that is close/next to/not far from the ramp access.

There are no bicycle parking facilities equipped with bicycle racks. In photo (B): household items (wooden racks, water tanks, used tires, etc.) and stalls (carts) owned by residents living around the park area are clearly visible, taking up the parking area. So that circulation on area parking is disturbed, as well as not friendly for disabled.

According to the technical provisions in PUPR Regulation No. 14 of 2017 and NDA references, parking of 4 or 2-wheeled vehicles must facilitate the needs of the disabled. The standard for 4-wheeled parking is vertical/horizontal (not diagonal) with a width of 2.4-3.6 m and a length of 4.8-7 m. There is free space to maneuver a wheelchair with a minimum width of 120 cm. The number of disabled parking needs is adjusted to the number of disabled people identified in the sub-district/district area. Paving in the parking area, free from gaps/holes, with clear markings/contrasting colors. For 2-wheeled vehicles, the minimum parking area is 0.7x2 m. There is a bicycle parking area with parking dimensions of 0.8x1.2 m.

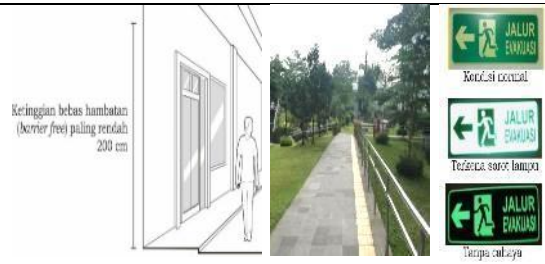
Table 11 East Segment Pedestrian Path

The pedestrian path consists of hard material/pavement in the form of non-slip terrazzo tiles. There is a 90 cm high handrail with square hollow material on the left side. On the right side there is a planter box containing shrub vegetation and groundcover in the form of grass as a soft material element that limits the pedestrian area with other open areas. Furnishing elements along this path that are found are garden lights and flower/plant pots. The width of the pedestrian path is 120 cm. Problems found in photo (A): there is no guide path, there are no directional signs and evacuation routes, and there are obstacles in the form of different level steps. In photo (B): there is a decrease in the ground level on the pedestrian path, so there is a slope that makes it uncomfortable for road users. In photo (C): there are objects/goods (trader equipment) placed by the community around the park area that block the accessibility of the pedestrian path. Likewise, there are plants (trees) whose branches/twigs are not high enough from 2 m, so that they also bother a c k pedestrian.

According to the technical provisions in PUPR Regulation No. 14 of 2017, there must be a guide path (direction and warning) for people with disabilities. The minimum barrier-free height is 200 cm from the floor. Besides It requires signs and markings indicating directions and evacuation routes, other signs related to assembly points/muster points.

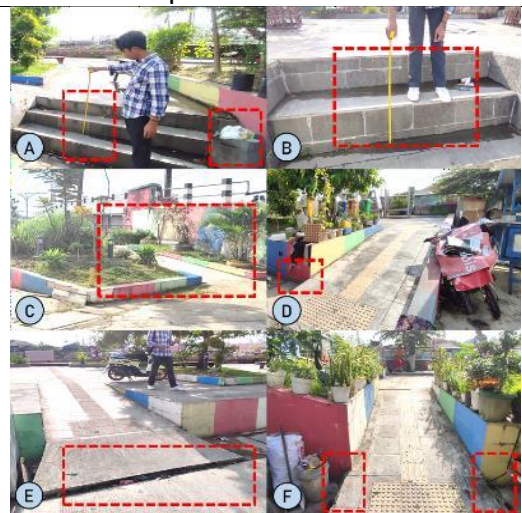
Table 13 East Segment Stairs and Ramps

In this eastern segment there are 5 stair accesses with varying number of steps from 2 to 3 steps. Then there are 4 ramp accesses for wheelchair users. The stair and ramp elements use pavement andesite stone or terrazzo tiles that are not slippery in texture, and some of the ramps are equipped with guide paths. Problems found in photos (A) and (B): the height (optride) of the steps is more than 18 cm which is the recommended size. The width (antride) of the steps is quite varied between 25-30 cm, without step nosing. In photo (C): a ramp with terrazzo tile paving is 130 cm wide, not equipped with guide paths and hand railings, the slope is around $<5^\circ$ and is equipped with a safety edge/curb. In photos (D) and (F): a 130 cm wide ramp with guide paths and warning tiles, the slope is around $<5^\circ$, not equipped with hand railings, there is no curb at the end of the ramp. In photo (E): a 130 cm wide ramp with guide paths and warning tiles, the slope

around $<5^\circ$, not equipped with hand railing, there is no curb at the end of the ramp and there are obstacles that make it difficult to move a wheelchair.

According to the technical provisions in PUPR Regulation No. 14 of 2017, the recommended height for steps is ideally 15-18 cm, whereas width must be at least 30 cm with added step nosing and additional lighting on each step. As for the ramp, the recommended one is with a maximum slope of 1:12 (5°) outside the building, and 1:10 (6°) inside the building. The ideal width is at least 120 cm for wheelchair paths and is equipped with guide paths and warning tiles. Every 900 cm between points, a landing must be added and a safety edge/curb must be added at least 10 cm high. Both stairs and ramps need to be added with hand railings as safety fences and also as an aid for users. Based on reference NDA, gap/hole on road surface/drainage of at least 1 cm so as not to endanger users.
